Emergency response to **Baige Landslide Dam** on the Jinsha River in China

Jianp ZHOU

Chief engineer of POWERCHINA Corp., Ltd.

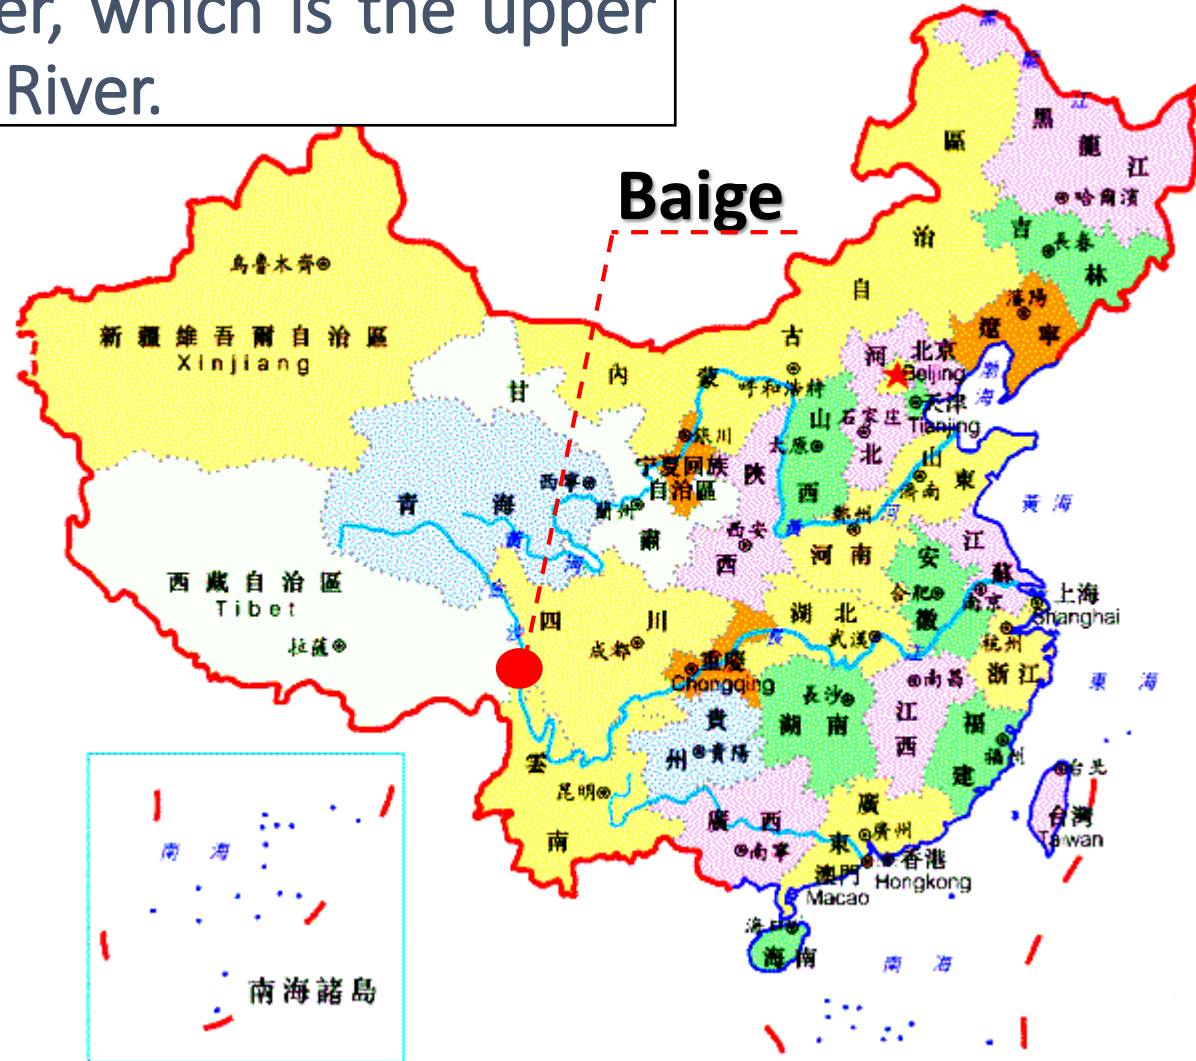
Landslides at Baige Village

On **Oct.10** and **Nov. 3, 2018**, **twice**, landslides blocked the Jinsha River, which is the upper reaches of the Yangtze River.

The big river was blocked by the landslide at Baige village, it **caused widely societal concerns**

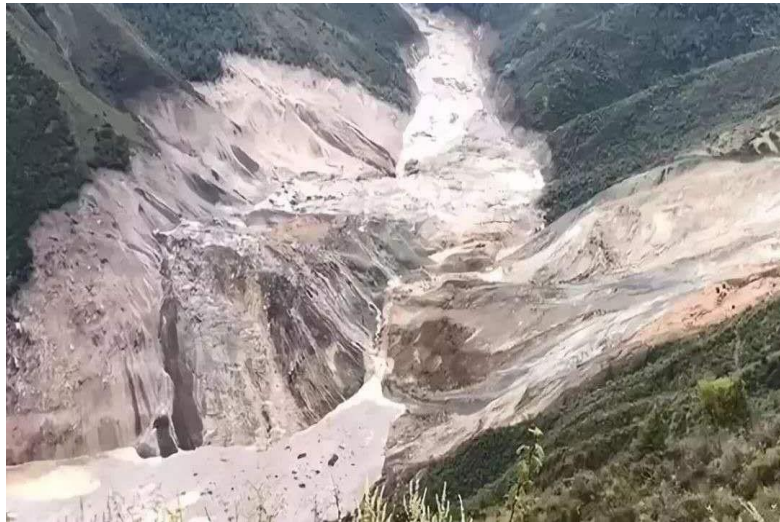
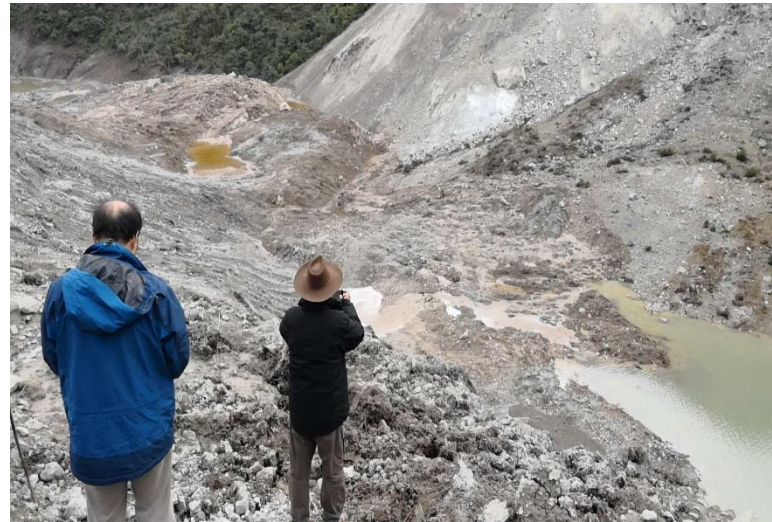
The 1st time: Baige Landslide Dam

The 1st landslide occurred on **Oct.10 at 22:00**. It is caused by the left bank landslides **without rain and without earthquake**.

The barrier roughly **1000m** long and **200m** wide and **60 to 120m** high with **volume of 25 million m³**.

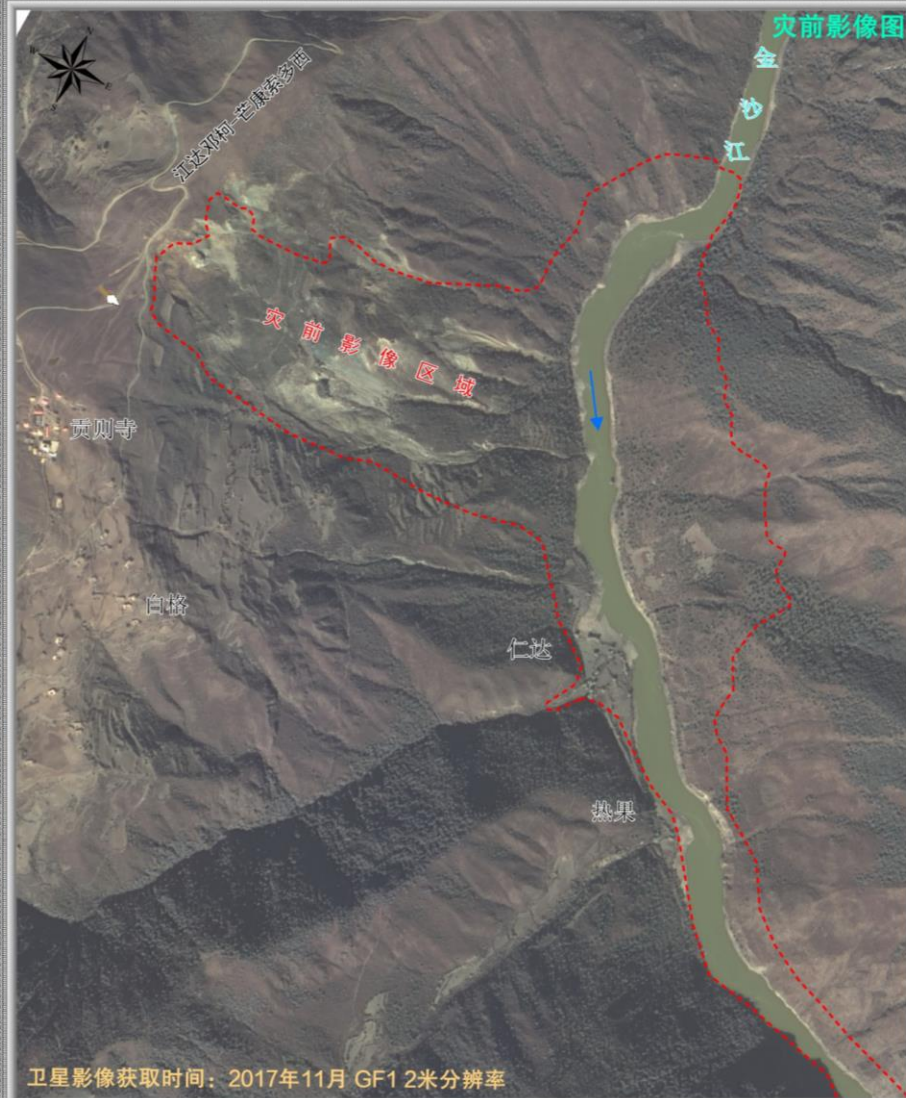
According to the assessment of the barrier and the inflow, **the Barrier will be break naturally soon when overtopping.**

The overflow began at 17:20 on Oct. 12, and peak discharge **10,000m³/s** occurred at 5:00 on the next day.

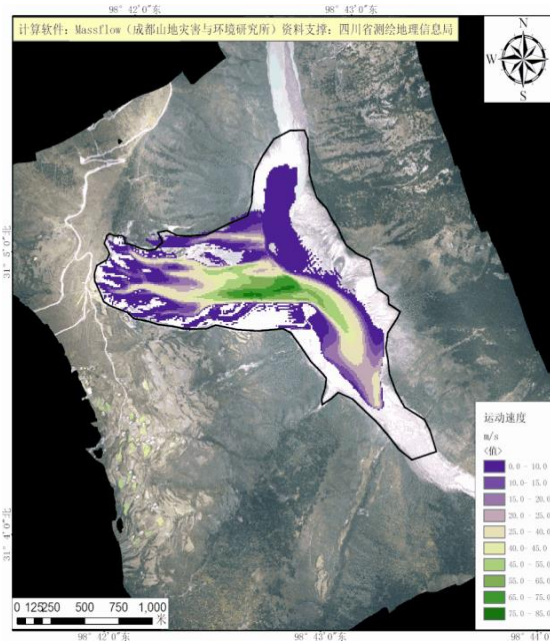
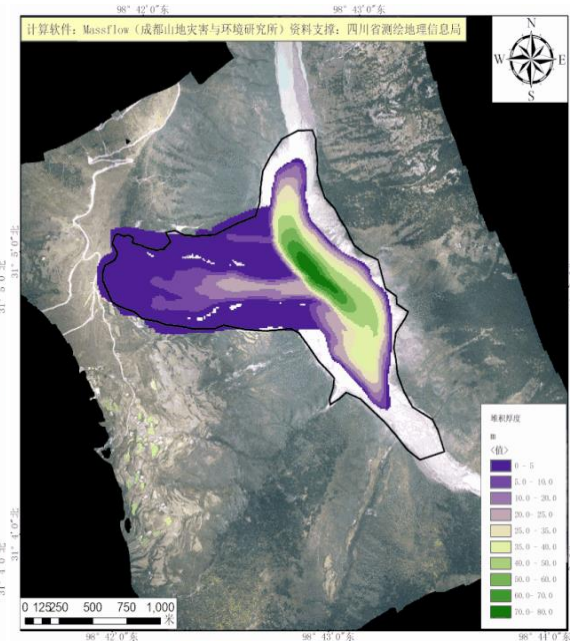
First time landslide

Evolution of landslide velocity and thickness

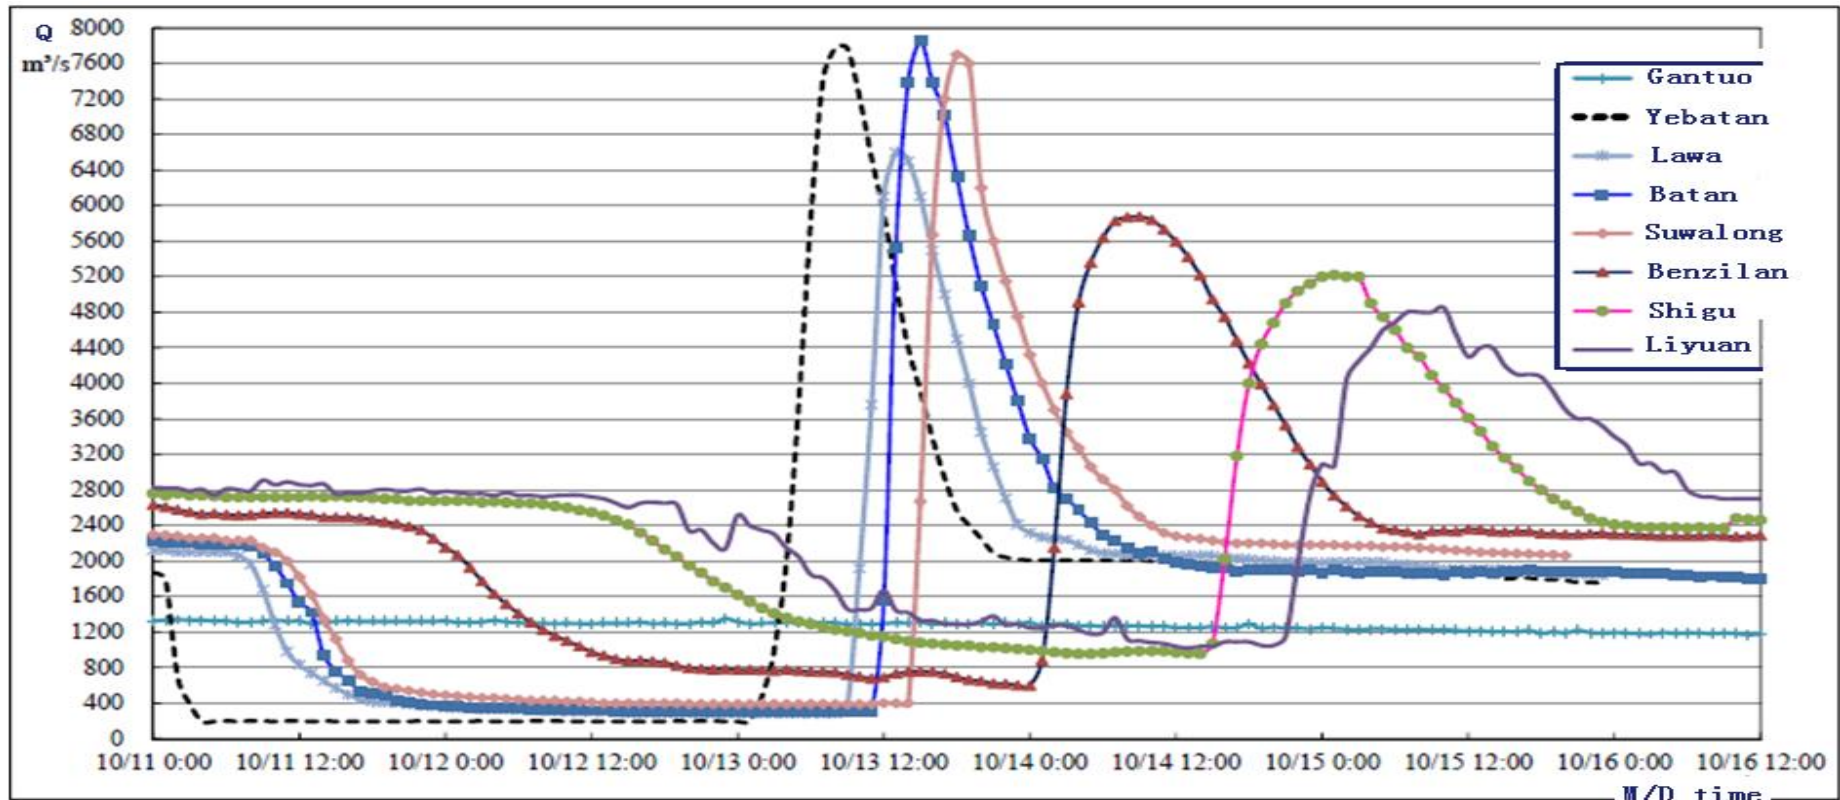
Measured flood Hydrograph after the Barrier break on Nov.13

As the flood routing to downstream, the peak discharge gradually decreases. Its impact totally lasted 5 days.

The flood routing hydrograph at each station were measured and recorded.

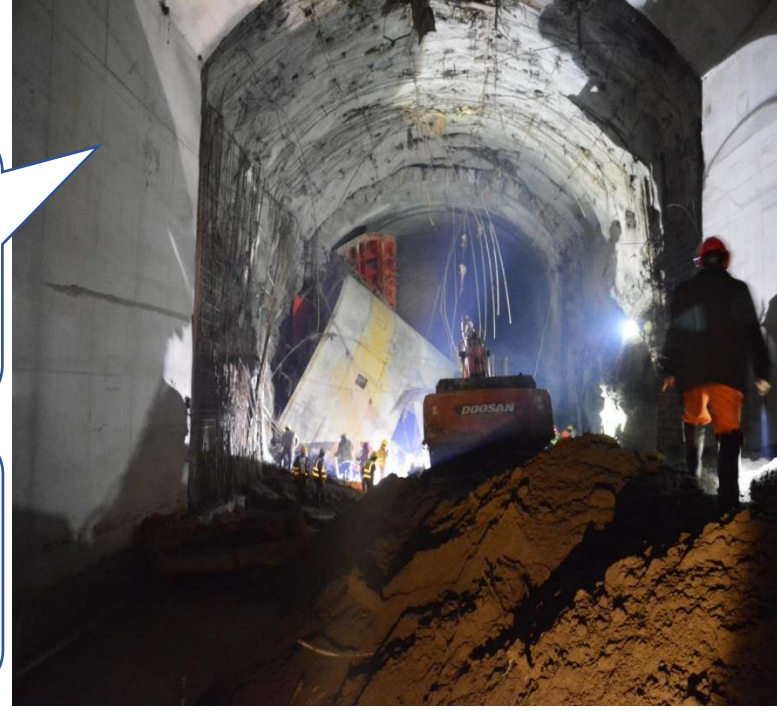
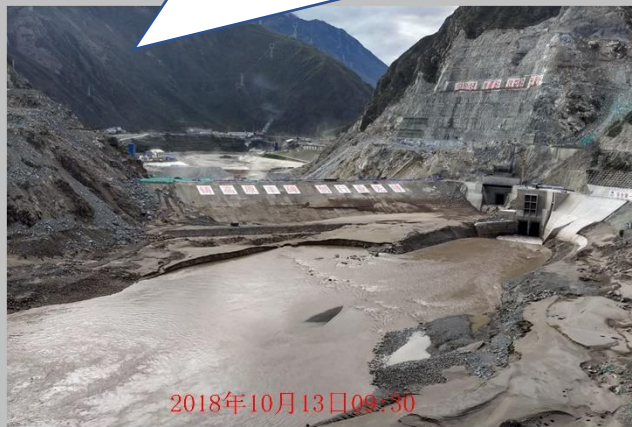
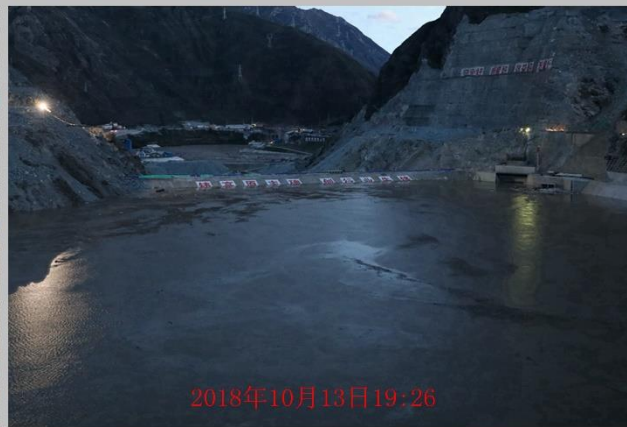
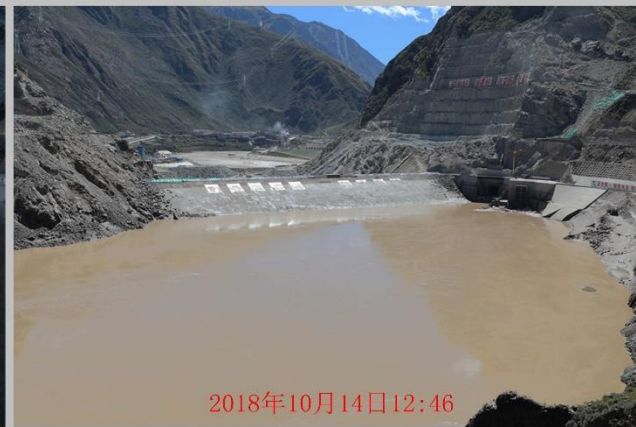
The 1st Baige landslide dam break caused locally some damages and losses.

Two diversion tunnels under constr. at the **Yebatan** were forced to flow through, flooding some roads and tunnels in the area.

The **peak discharge** reduced to 5,700 m³/s from 7,700 m³/s, due to the **Suwalong cofferdam retains flood.**

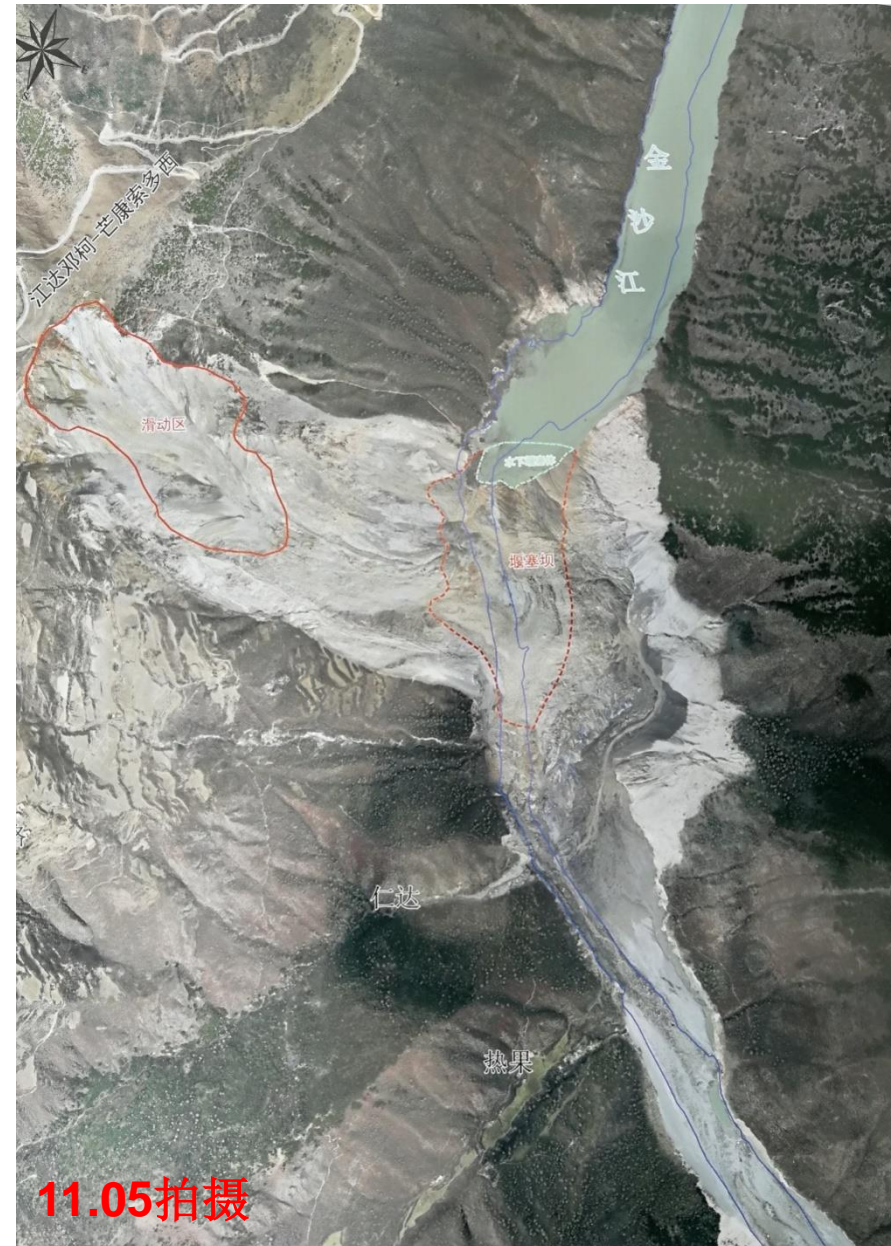
The 2nd time: Baige Landslide Dam

The 2nd landslide occurred at **17:40 on Nov. 3, 2018** at the **same site** on Jinsha River.

The volume of landslides 310 million m³ with the residual material of 1st landslide. The top El. of the Barrier is 2,966m, water storage capacity **775 million m³**, which will be **3.5 times** of the 1st barrier lake.

Much more danger!

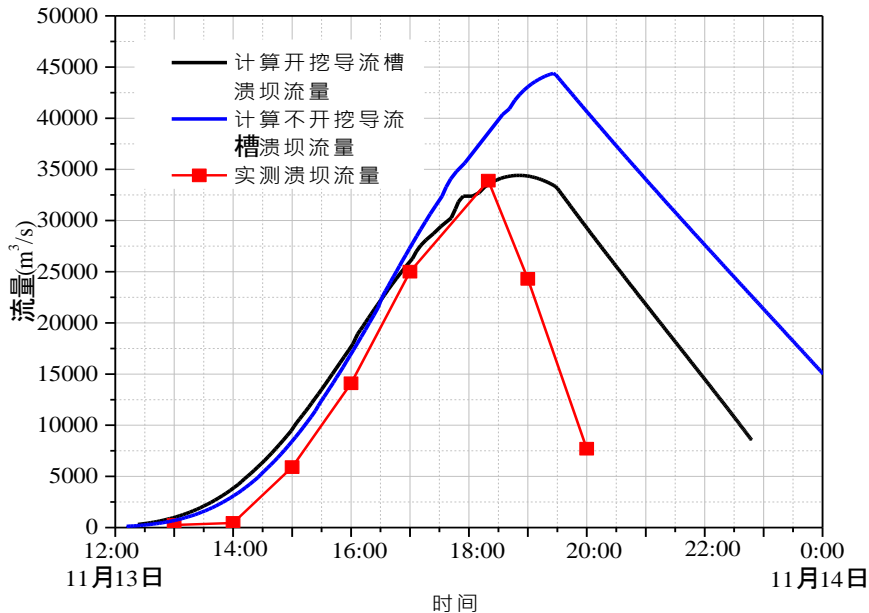
Cases	Peak flood (m ³ /s)	Arrival time after overflow (hr)	flow velocity at the ditch (m/s)
A-1	44670	7.6	9.0
A-2	37300	8.5	8.7

After the risk analysis, it is predicted that the flood peak is about **37,000 to 45,000 m³/s** without manual intervention.

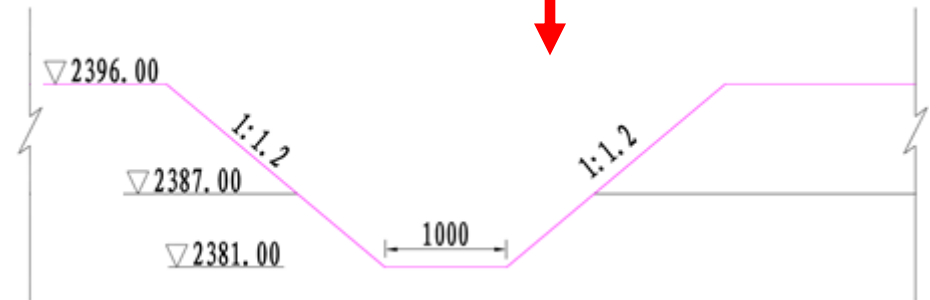
The design plan of Suwalong cofferdam dismantle

On Nov. 4, main three suggestions:

- 1) Artificial intervention---Excavation diversion Channel
- 2) Suwalong cofferdam dismantle
- 3) Liyuan reservoir emptying in advance.

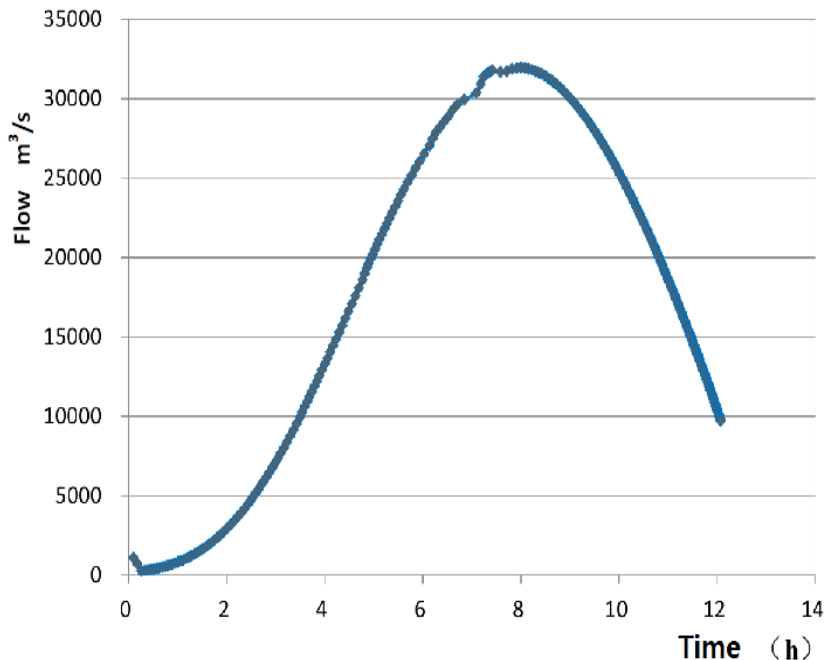
After cutting the ditch, the landslide dam breach flood max. 30,000 m³/s.

Flood hydrograph calculated by Xingbo Zhou on Nov 4, 2018

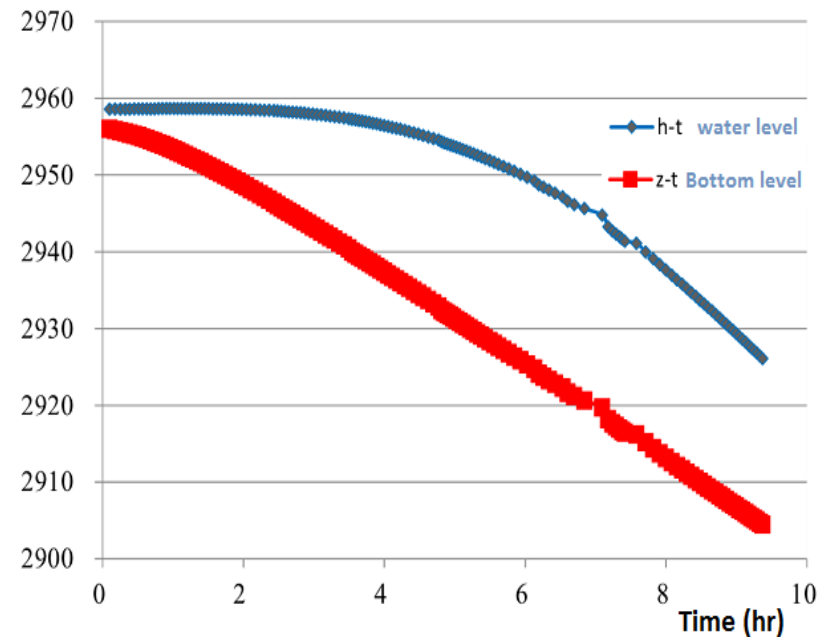
Calculated water level and bottom level of the trench by Xingbo Zhou

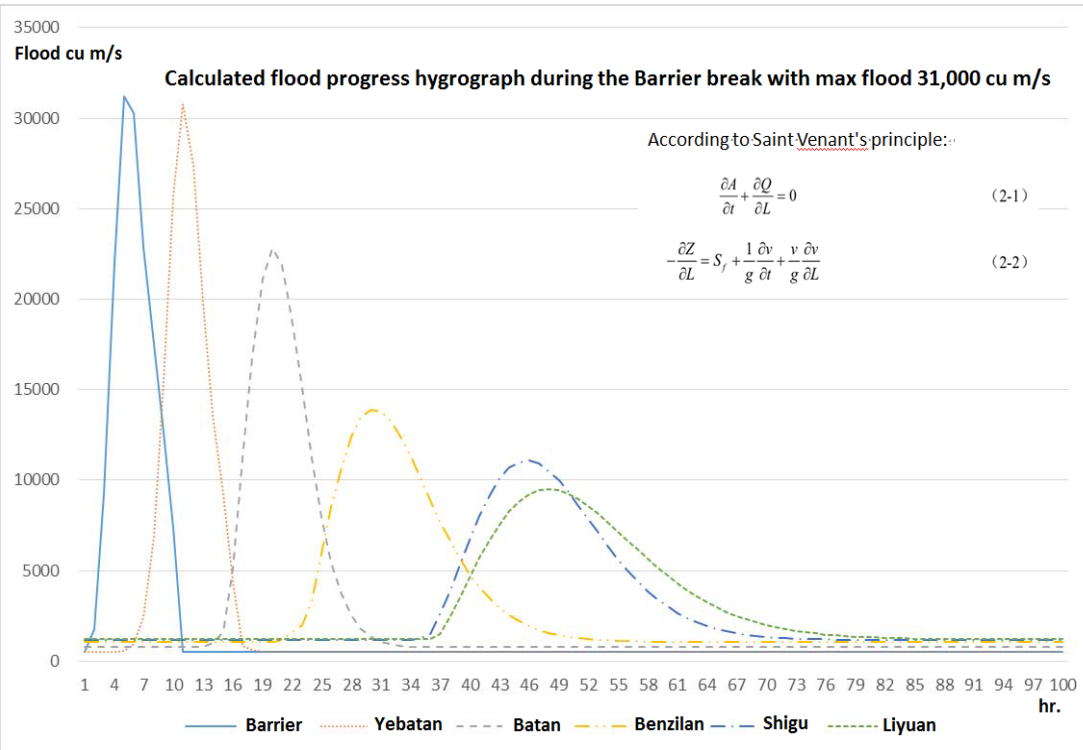
Then, analyzed the flood routing hydrography downstream

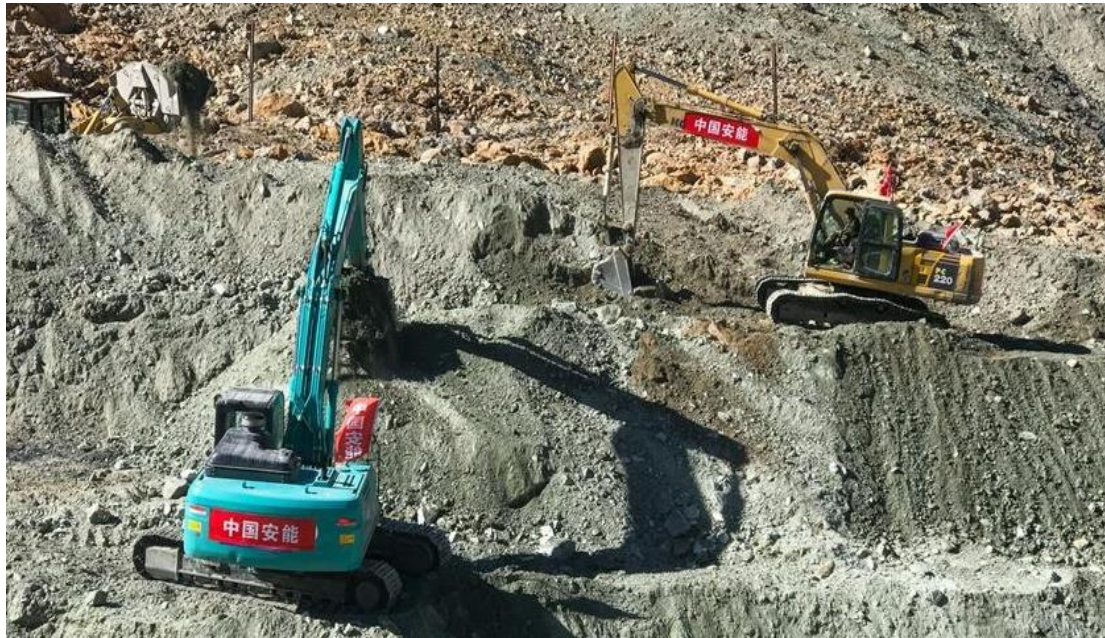
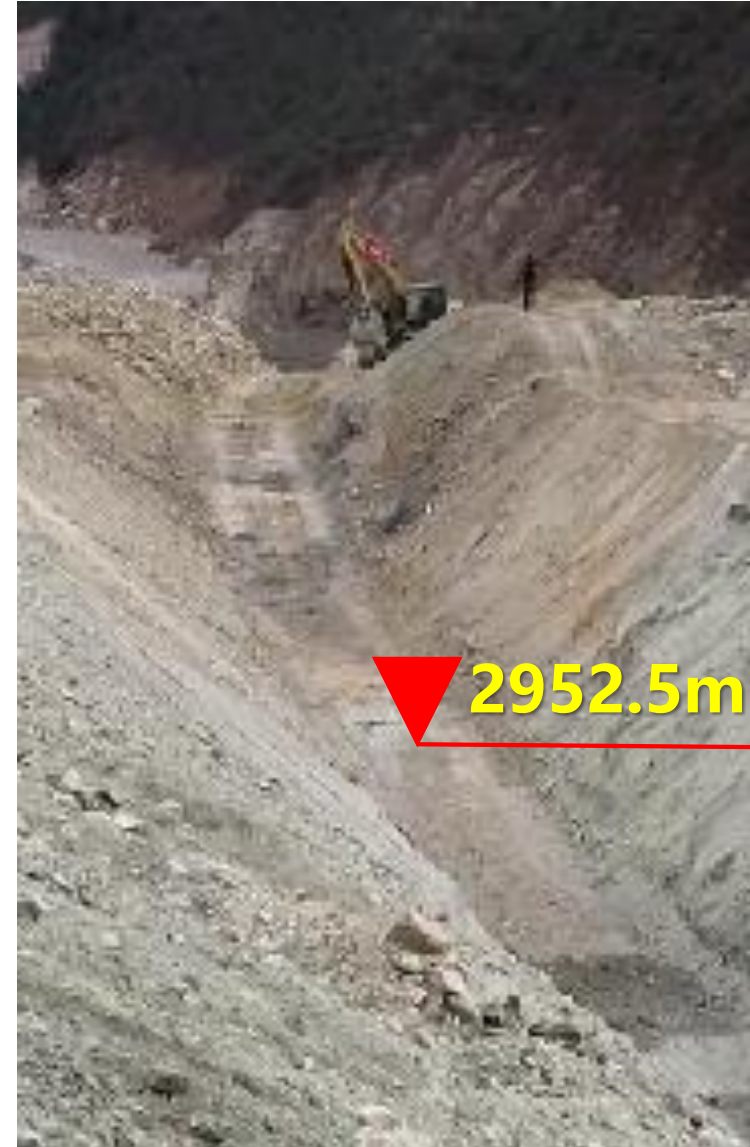
5 days later (on 8th Nov), first machine arrived at the top of the Barrier.

The man-made diversion channel was built at 17:00 on 11th Nov, 2018.

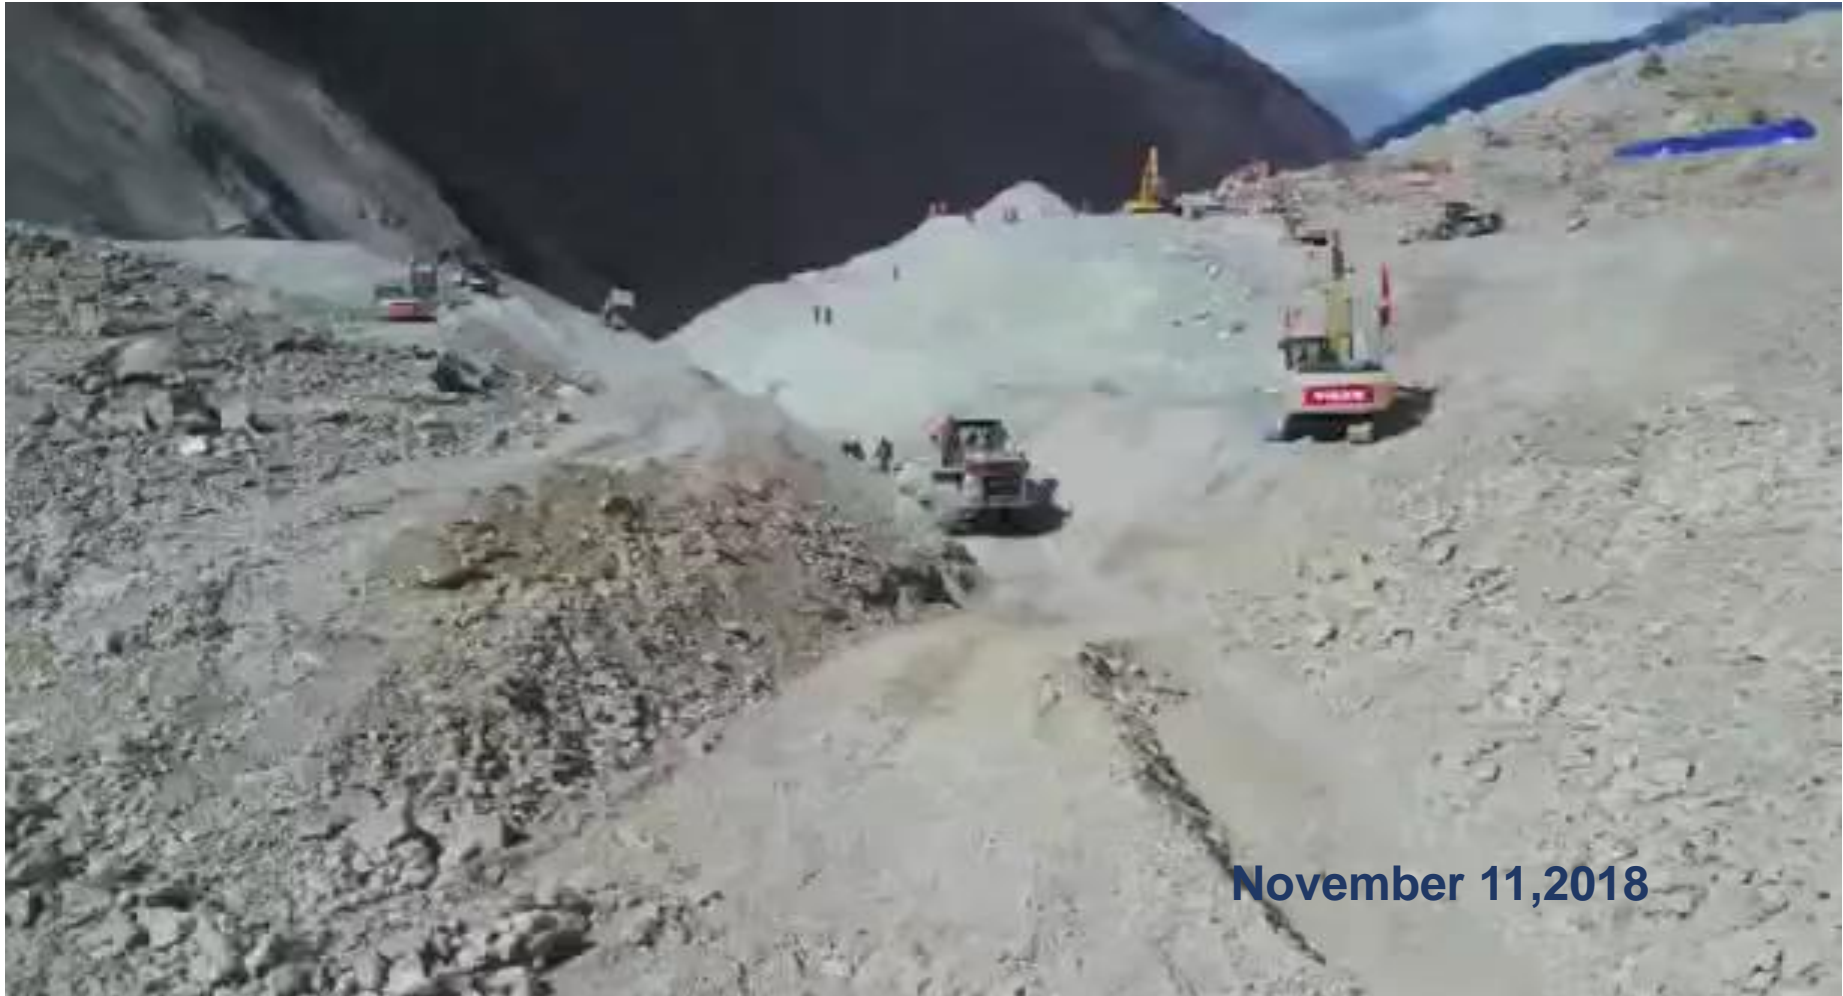
November 11, 2018

Man-made diversion channel under construction from 8th to 11th Nov.

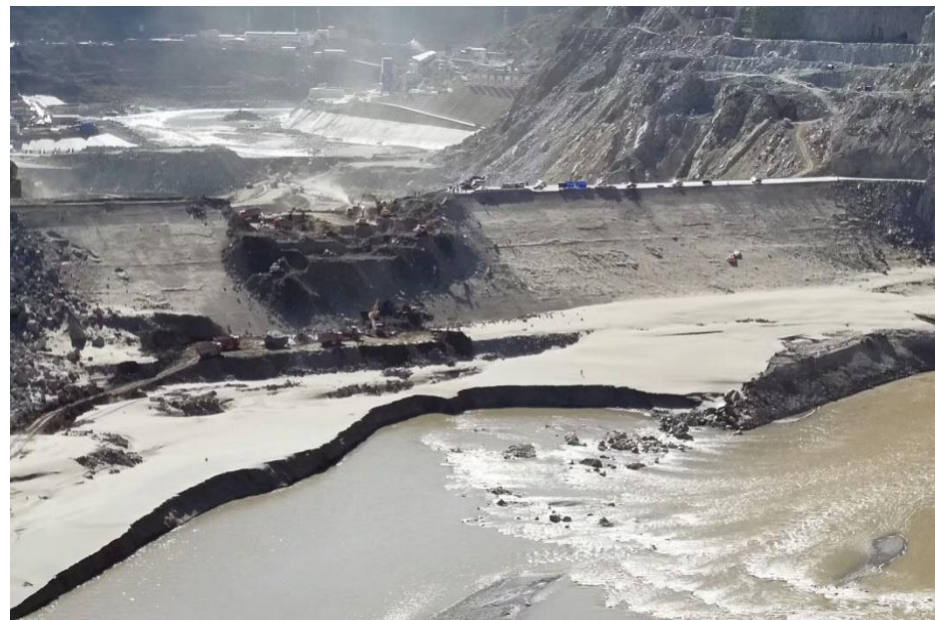
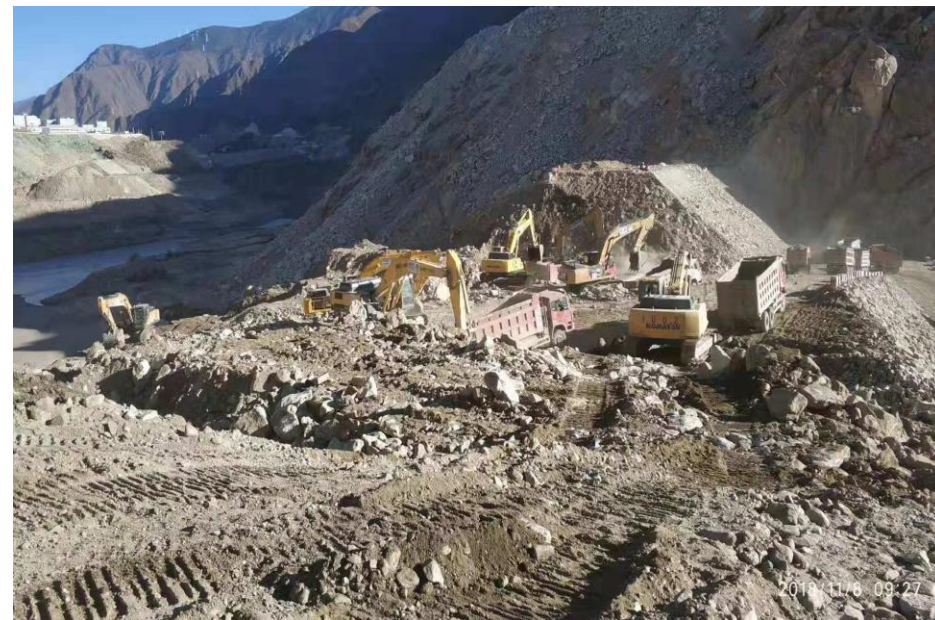
If the cofferdam is not removed, it will be also breach, and the water volume will be superimposed to the Barrier breach flood. **Dismantle began on 7th November.**

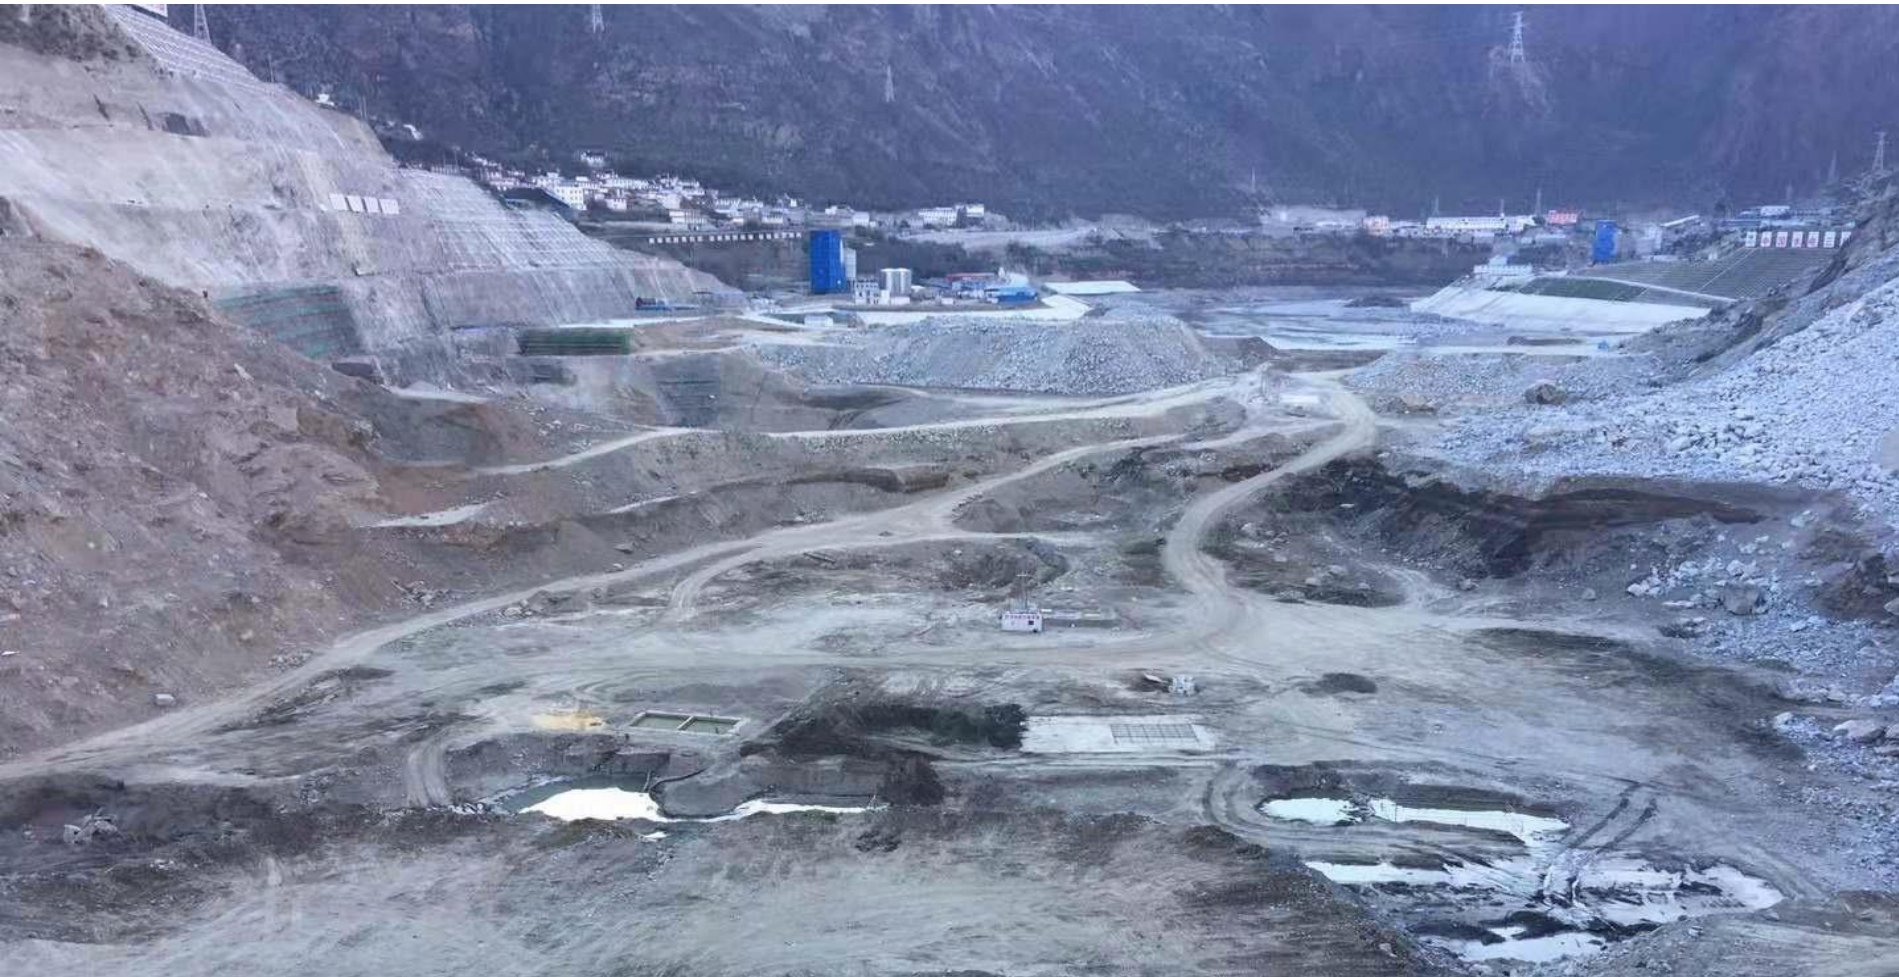
It was finished to remove cofferdam on Nov.10

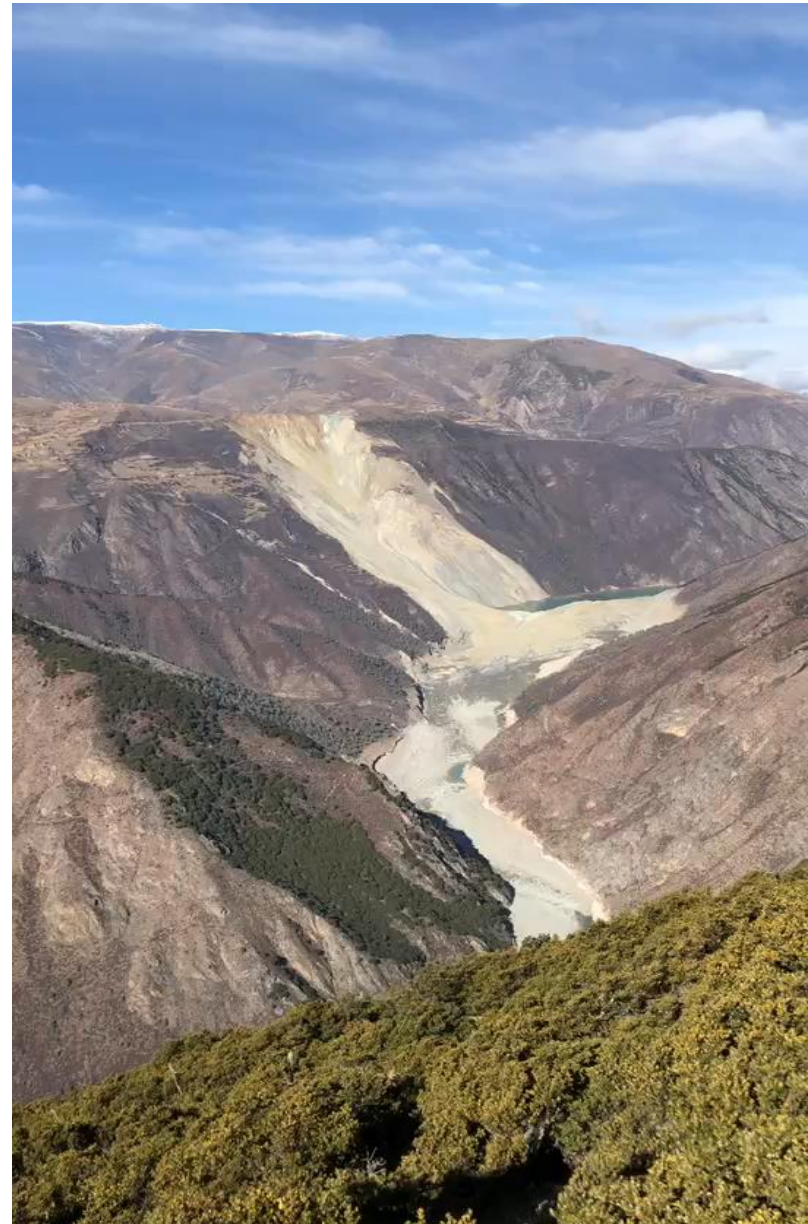
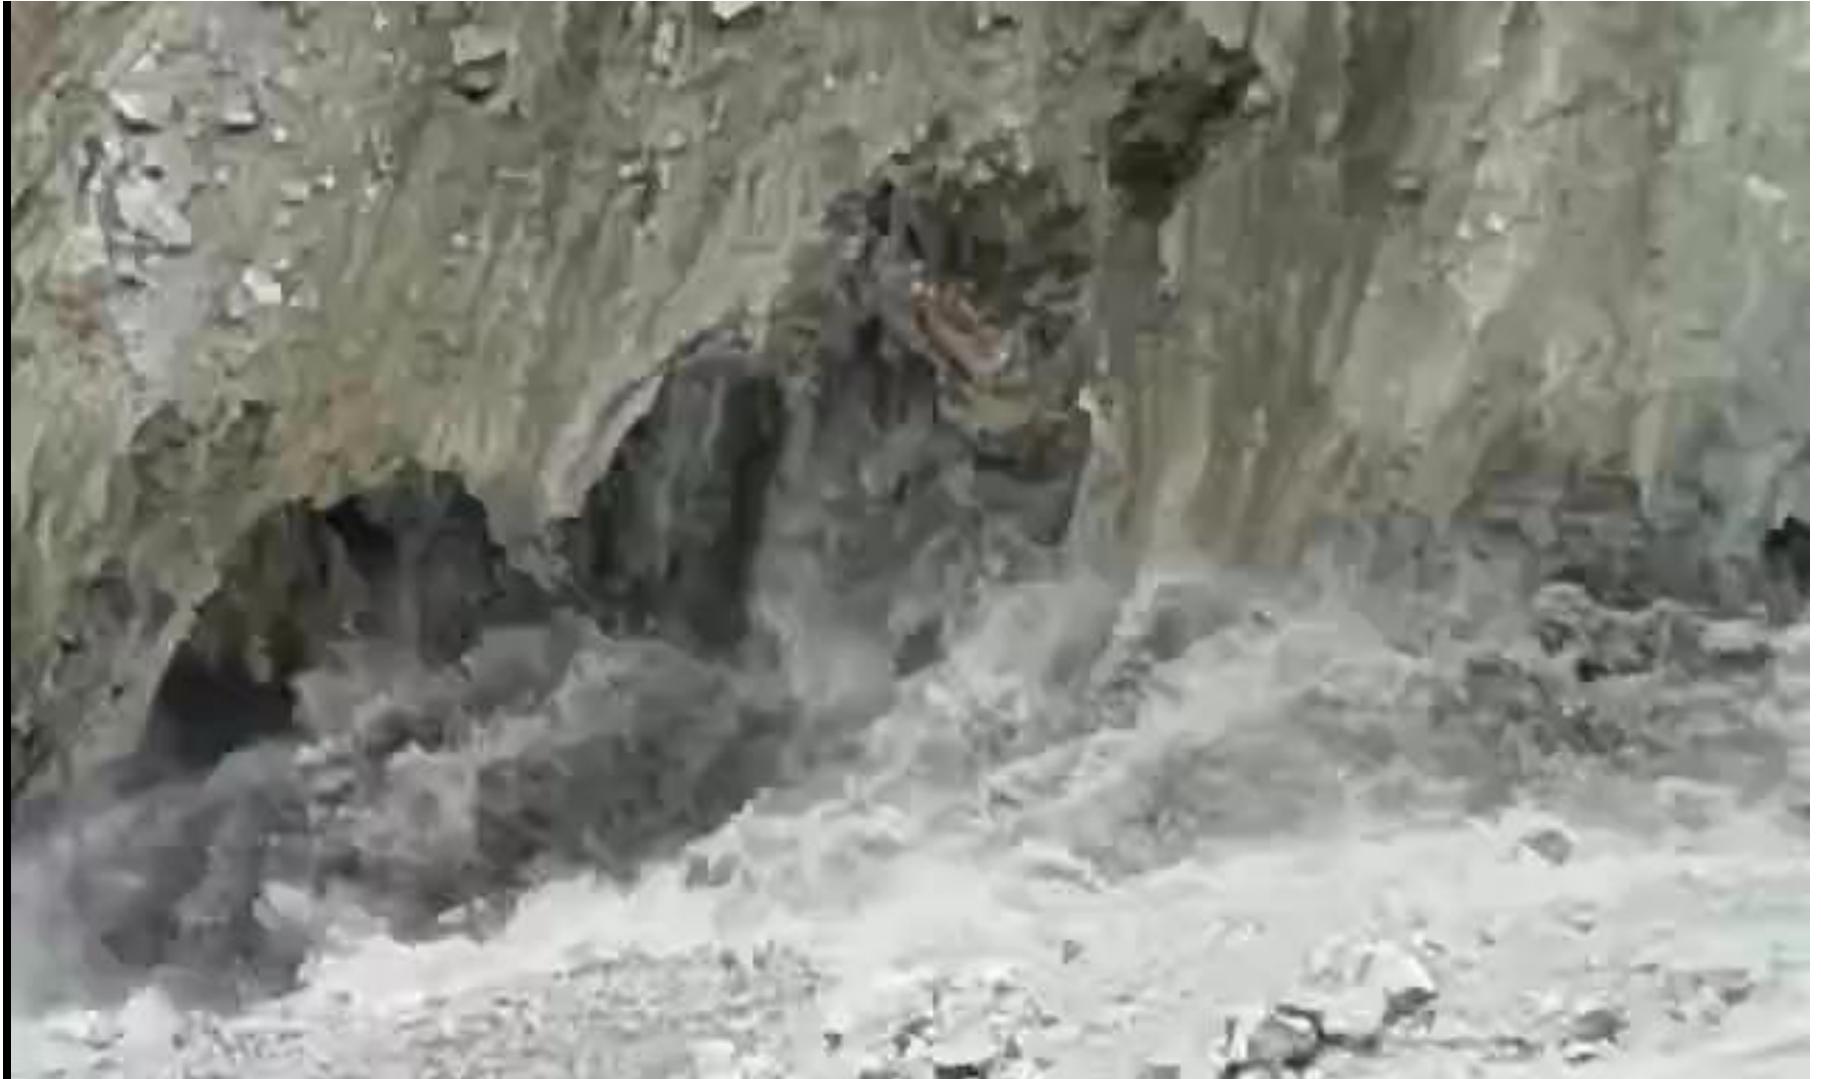
Baige Landslide dam Break 13 Nov 2018

At 5:00 am on 12th, the water level of the Baige barrier lake rose to the bottom of the man-made diversion channel.

At 8:00 on 13th, the Dam came into the breach stage, corresponding to the water level of 2955.76m **with water storage of 0.6 billion cu m.**

At 18:20 on 13th, the dam breach flood reached the peak discharge, measured to be 33,900 m³/s. in 10hr of the beginning of overtopping)

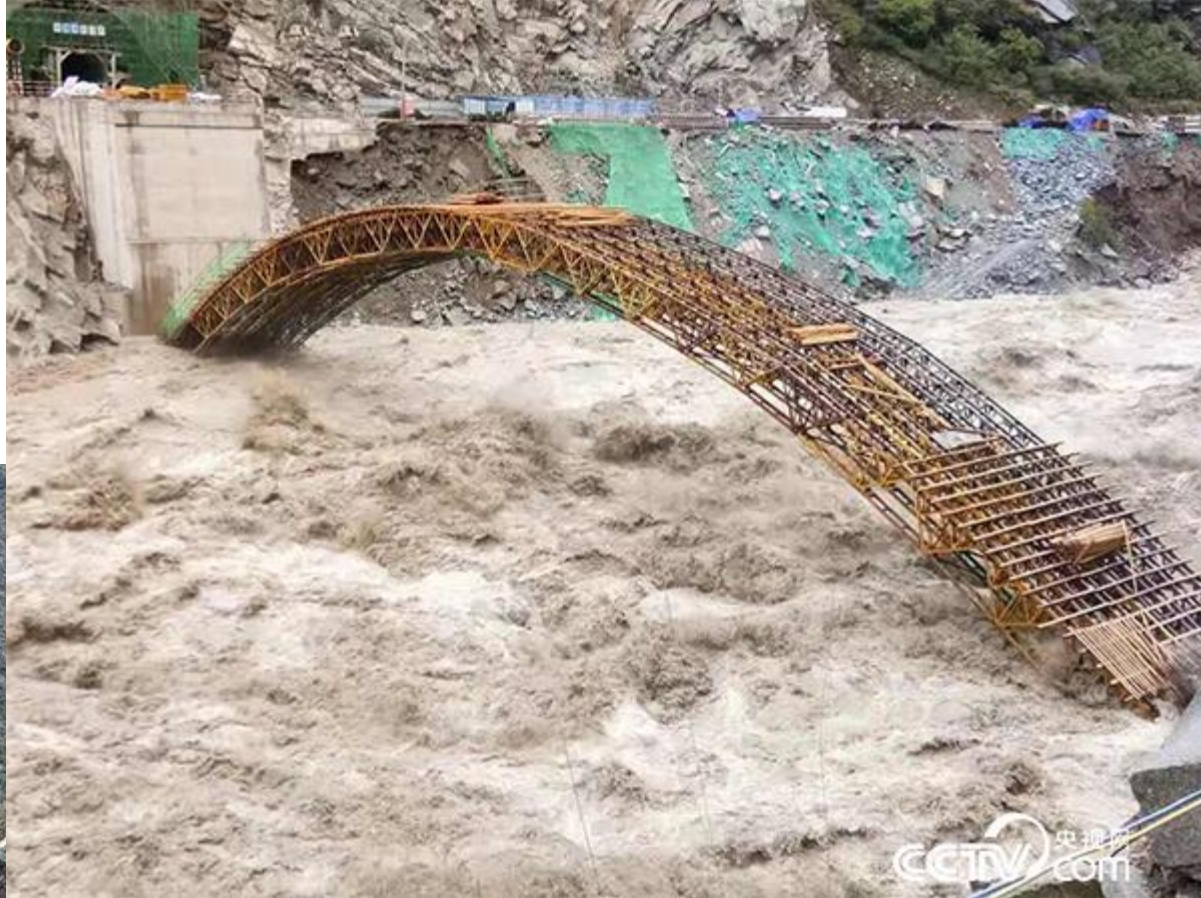
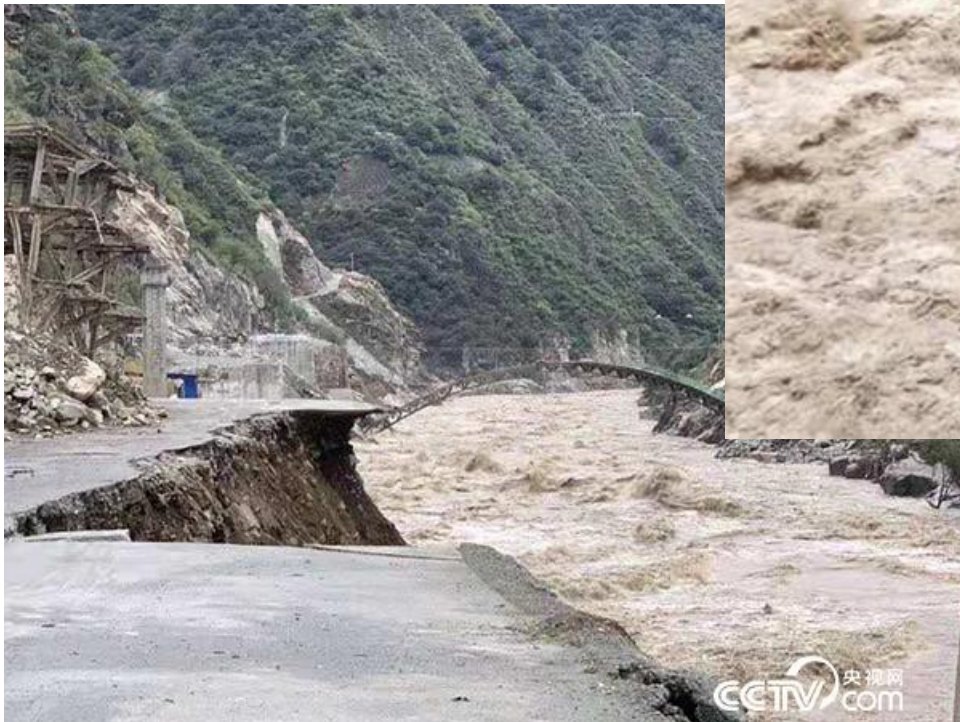
Yebatan HPS site

far away **54km** to the Barrier
