Emergency response to **Baige Landslide Dam** on the Jinsha River in China

Jianp ZHOU

Chief engineer of POWERCHINA Corp., Ltd.

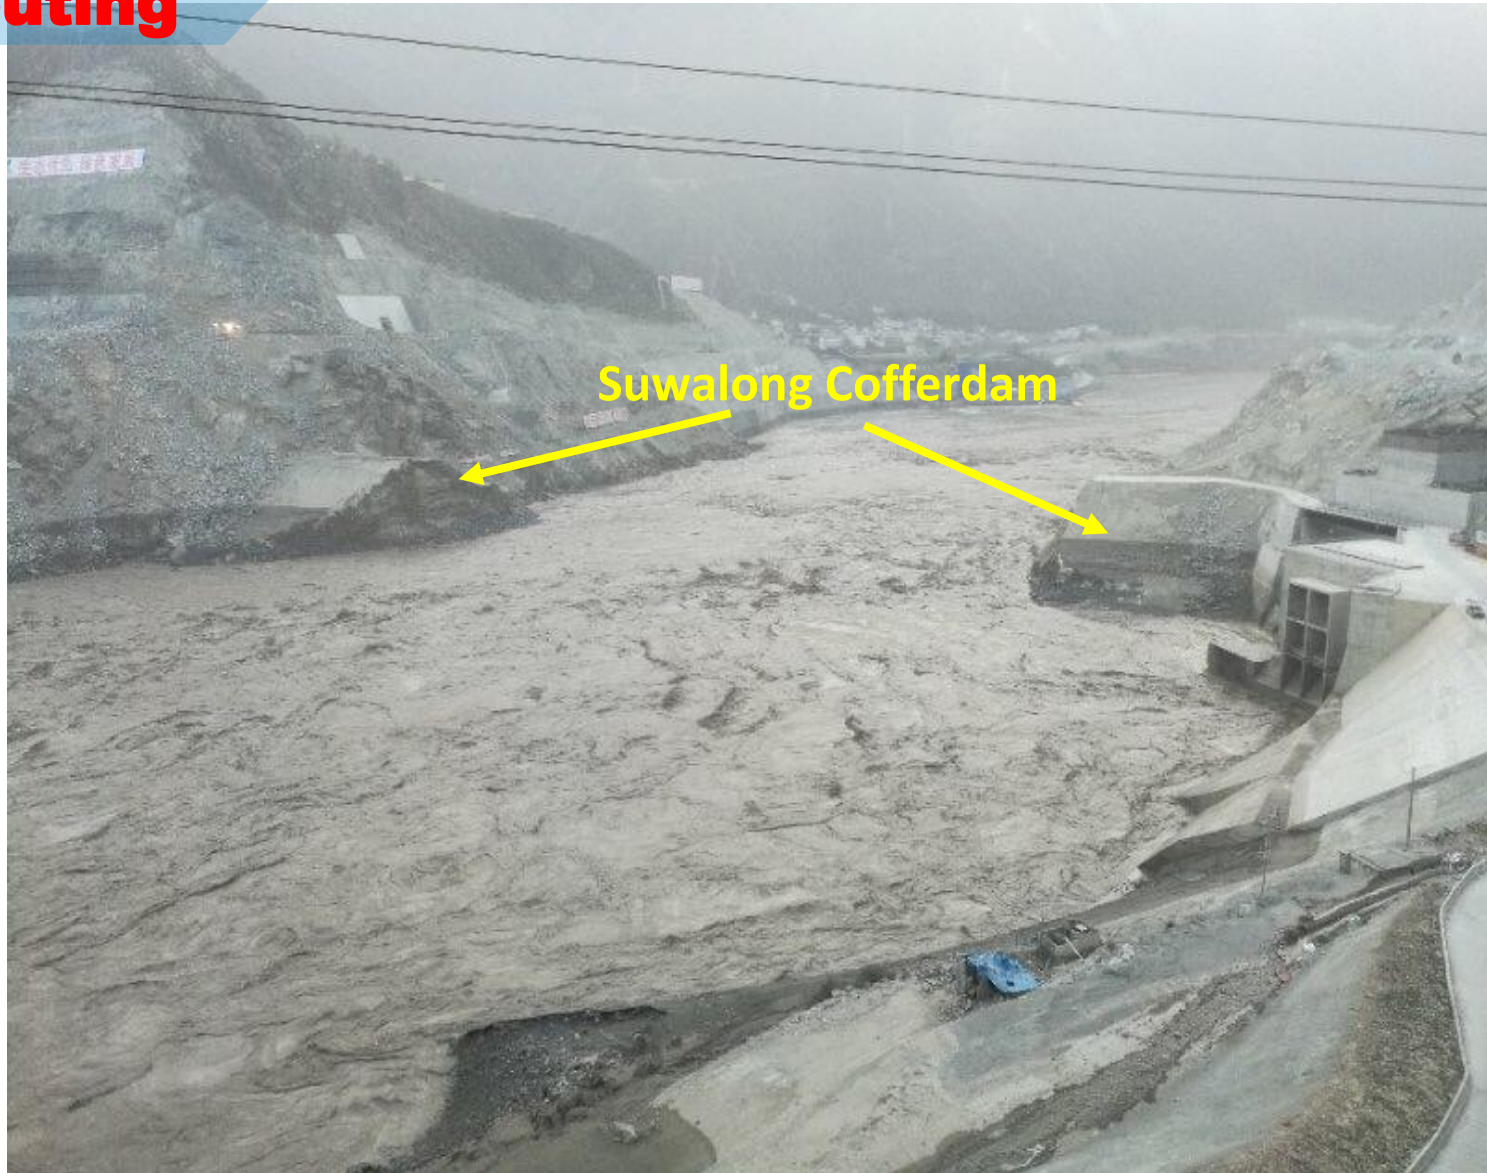
Suwalong
far away
224km to
the Barrier

Fmax
19,800m³/s
at 3:50 am on
14th Nov.

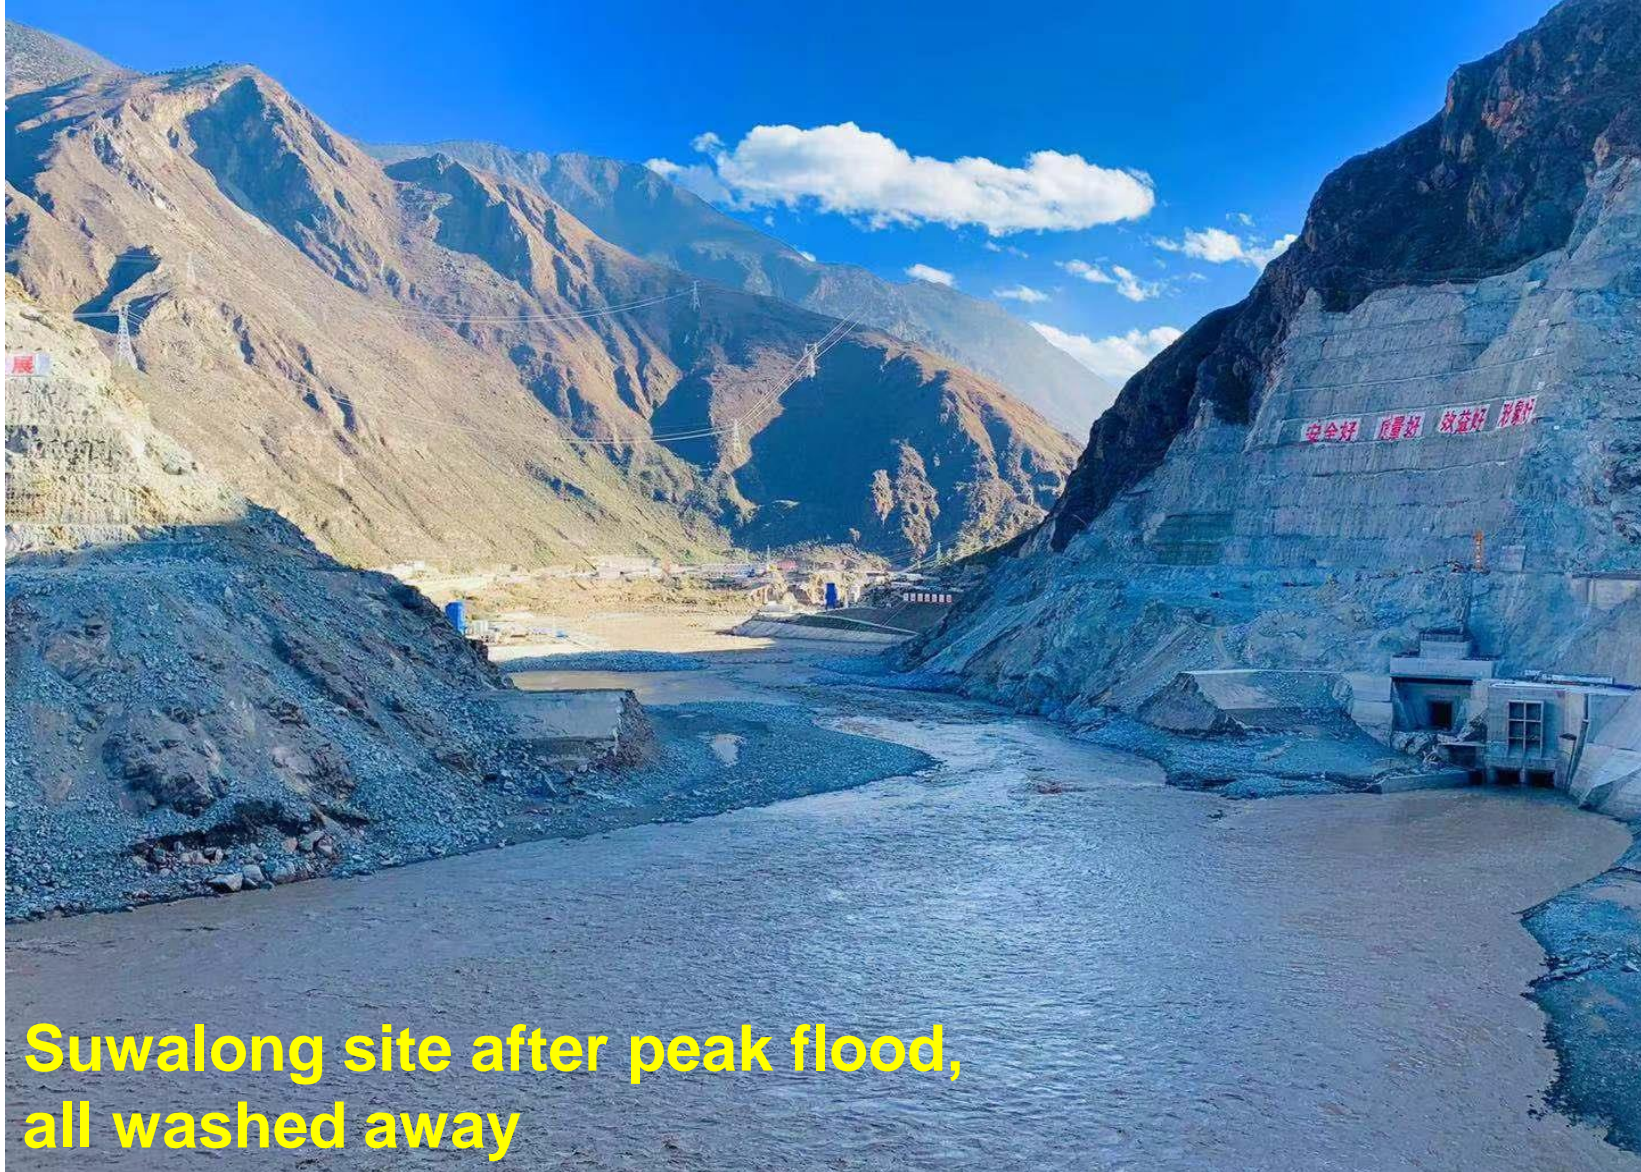
**Suwalong site after peak flood,
all washed away**

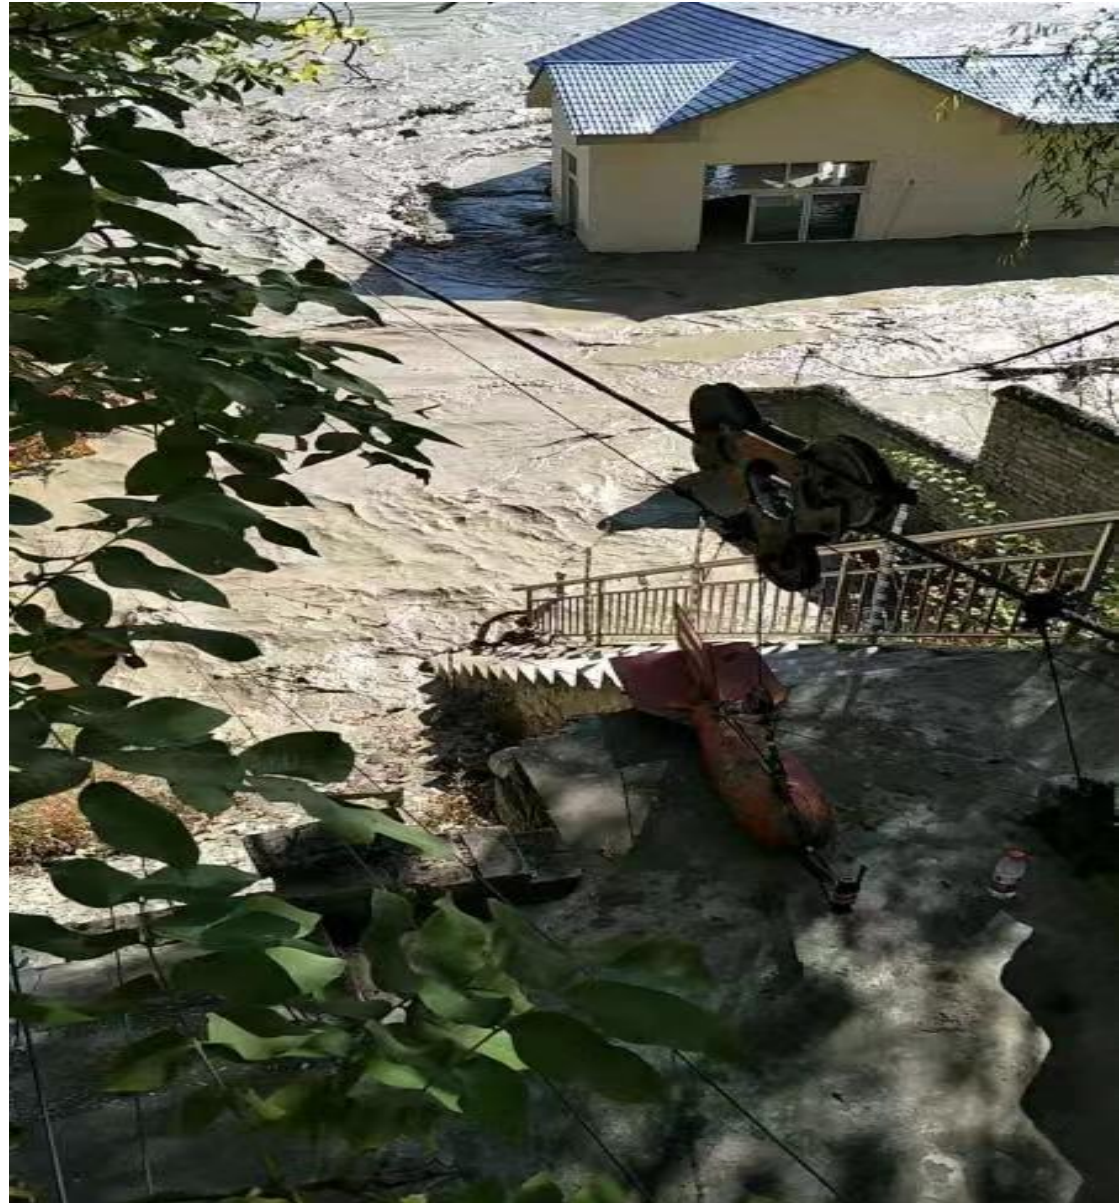
**Benzilan
Hydrologic
station**

far away **380km**
to the Barrier

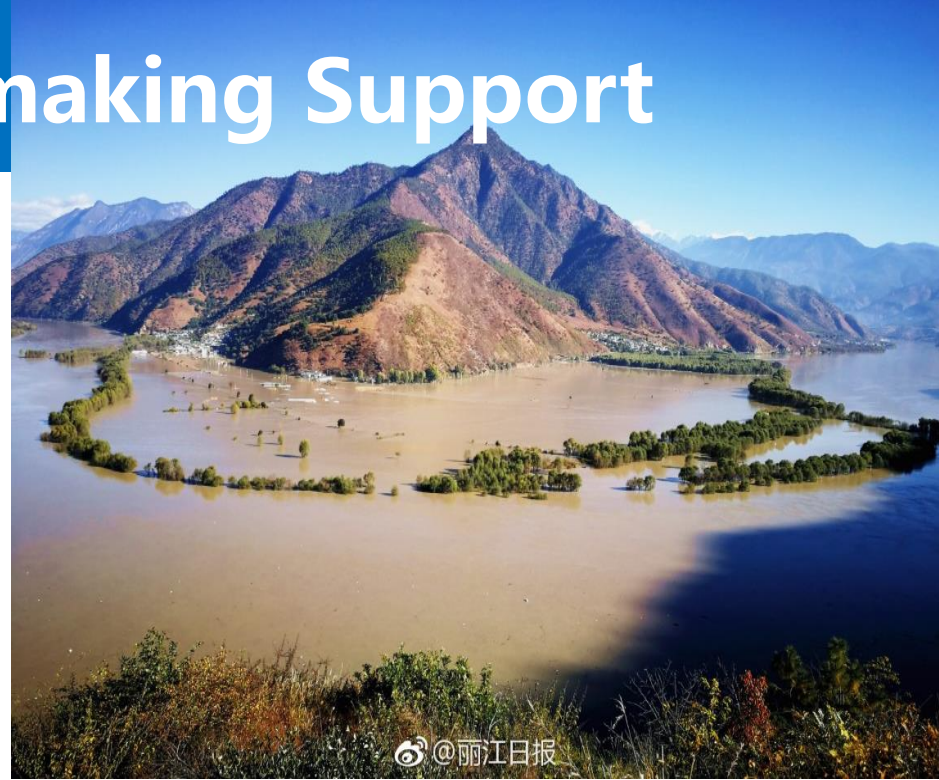
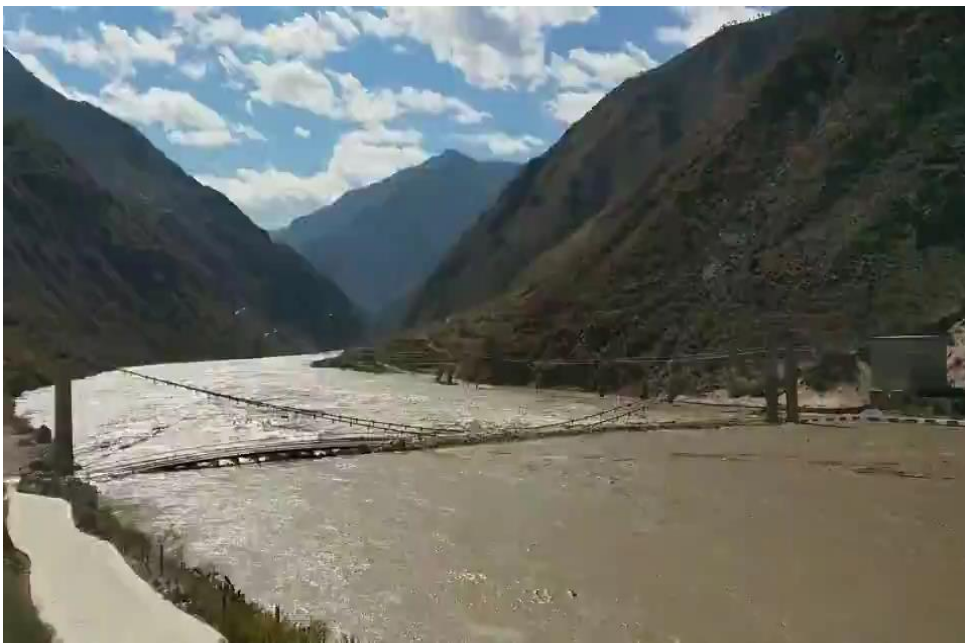
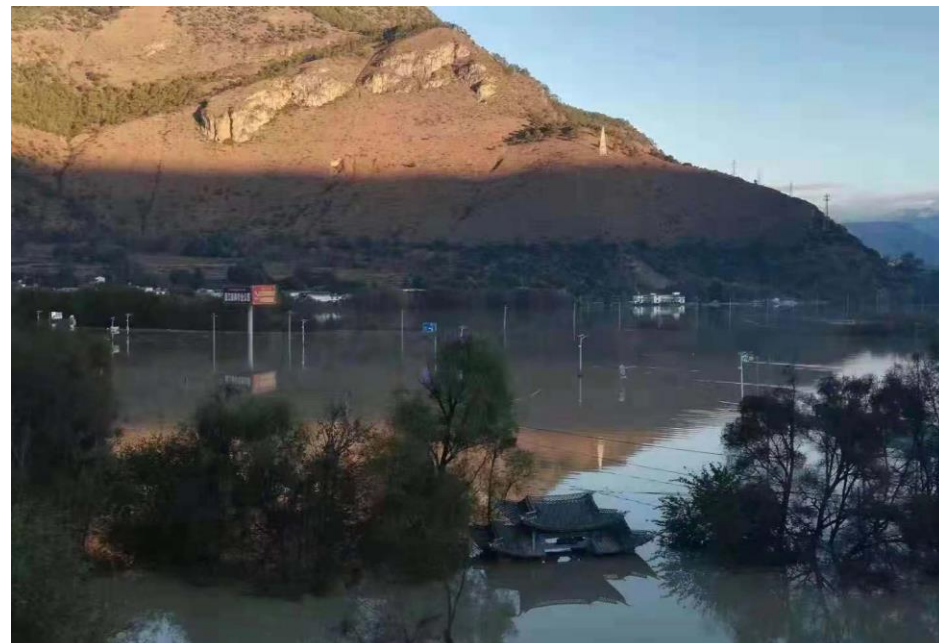
Shigu Town

far away **560km**
to the Barrier

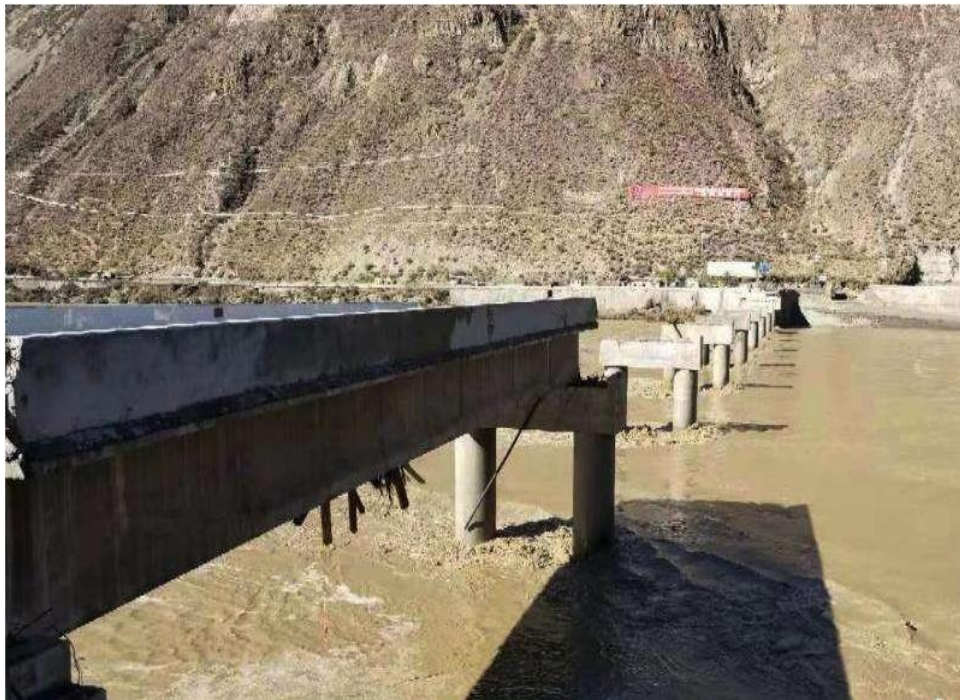
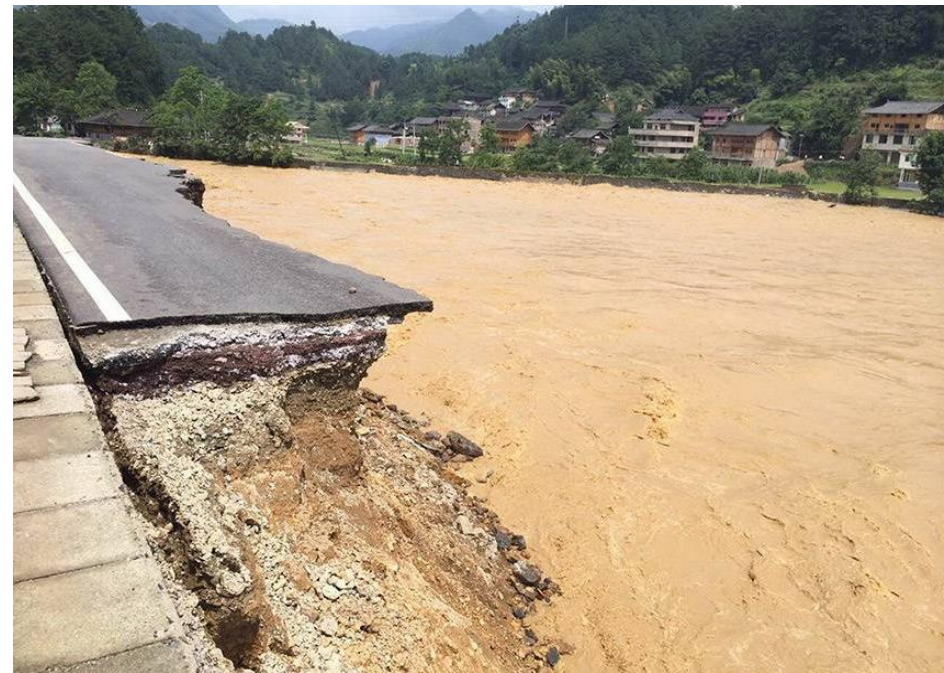
At least 7 bridges on the Jinsha River, hundreds national roads and other major infrastructures by the side of the River were damaged during 13-15 Nov., 2018.

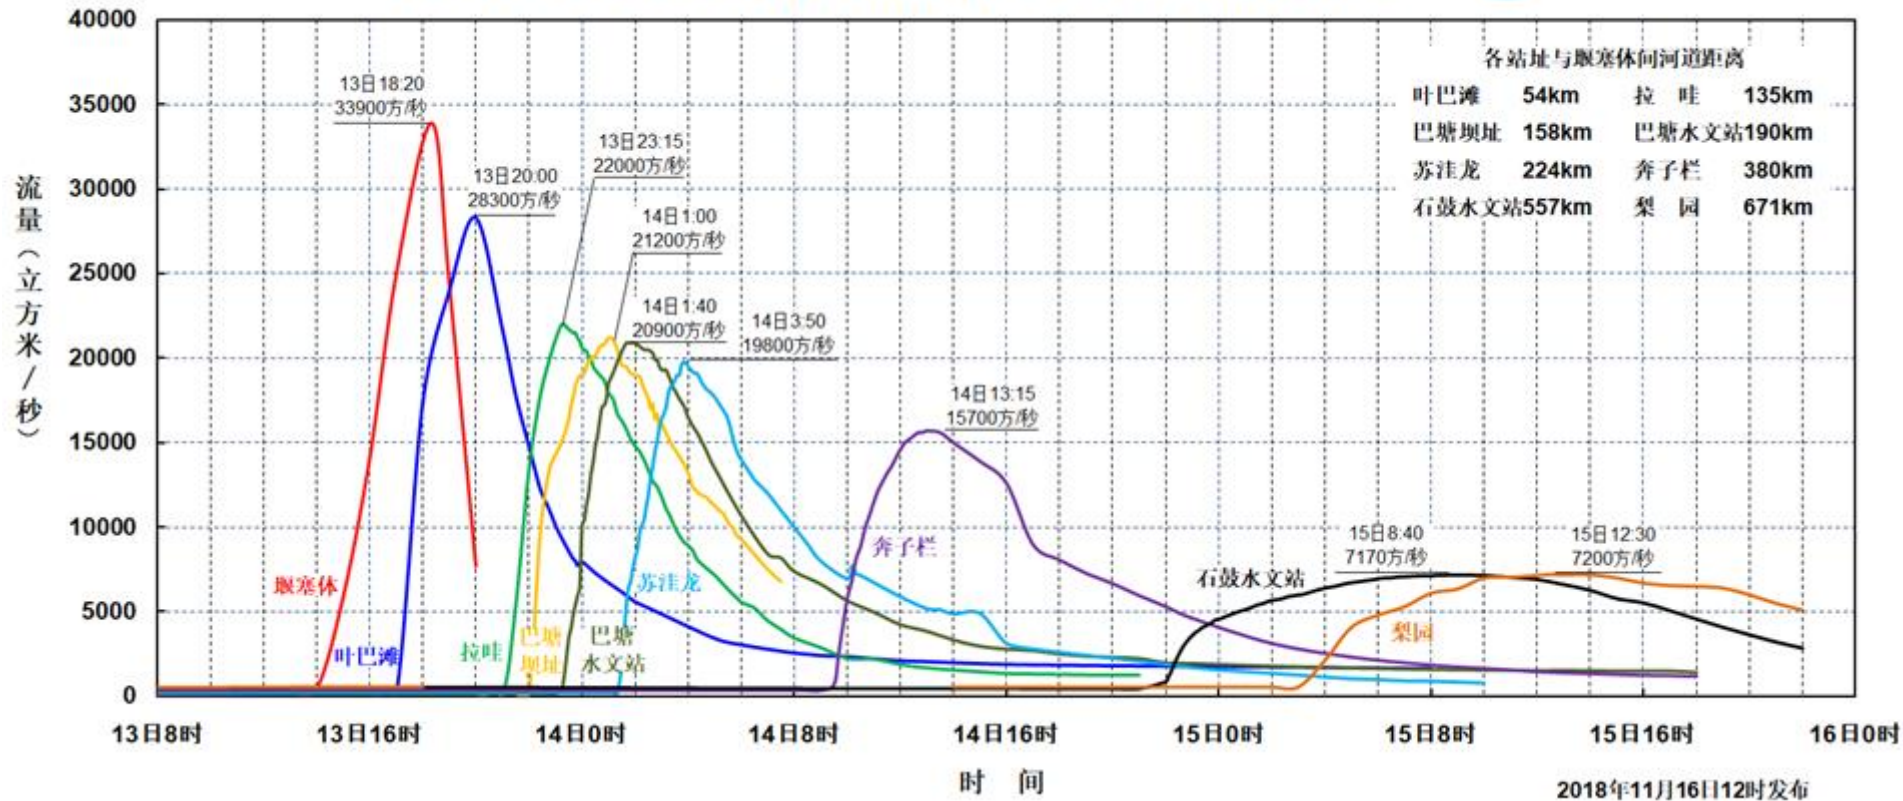
Measured flood hydrograph at the dam sites

The flood rapidly advanced to the downstream. The flood peak discharge to the **Yebatan** reached **28,300** m³/s at 20:00 on 13th. At 1:00 am on 14th, the flood peak discharge at the **Batan** station was **20,900** m³/s. The flood at **Suwalong** reached its peak at **19,800** m³/s at 3:50 am on 14th Nov. The inflow to **Liyuan reservoir** reached the maximum flood of **7200** m³/s at 12:30 on 15 Nov.

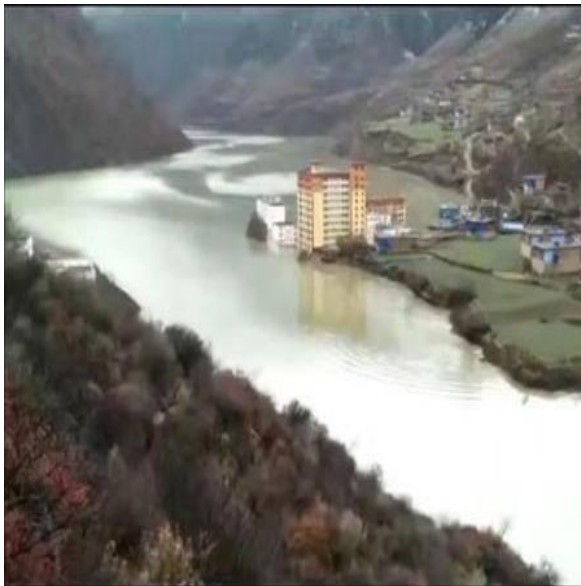
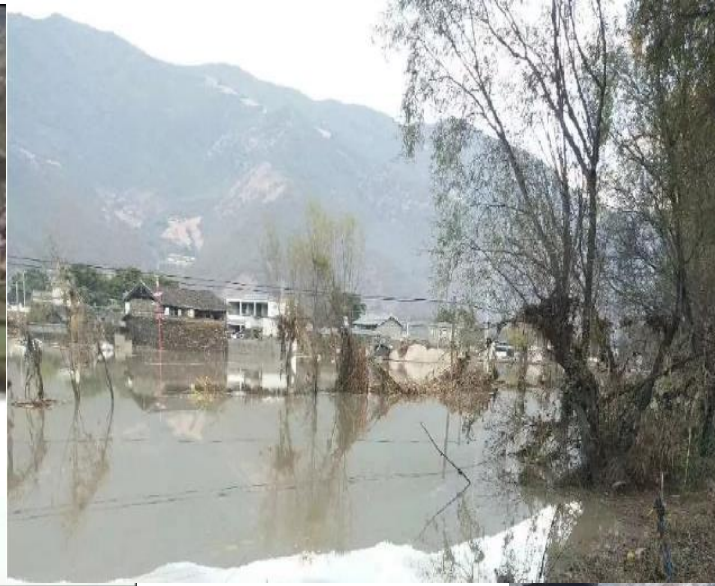
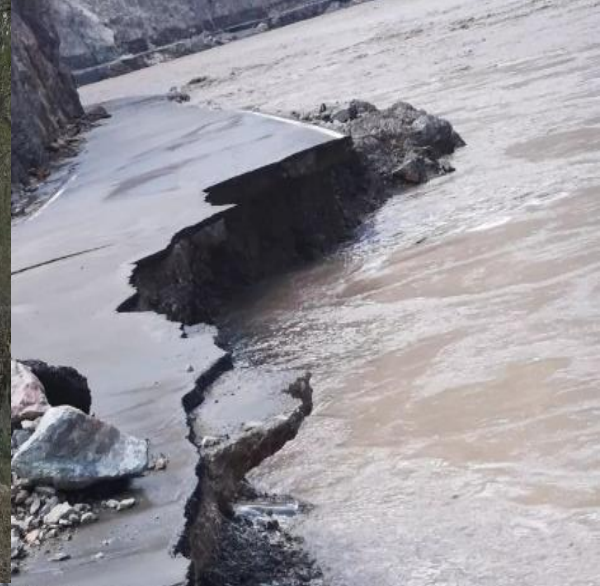
Yunnan Province suffered the most losses, followed by Sichuan and Tibet, approximately 1.2 billion, 0.6 billion and 0.5 billion USD respectively. With losses of hydropower stations under construction , **the totally losses were 3.0 billion USD.**
