ICOLD  
27<sup>TH</sup> CONGRESS  
90<sup>TH</sup> ANNUAL  
MEETING

# Studies on CSD and Applications in China

*Dr. Jinsheng JIA*

*Prof., IWHR, China*

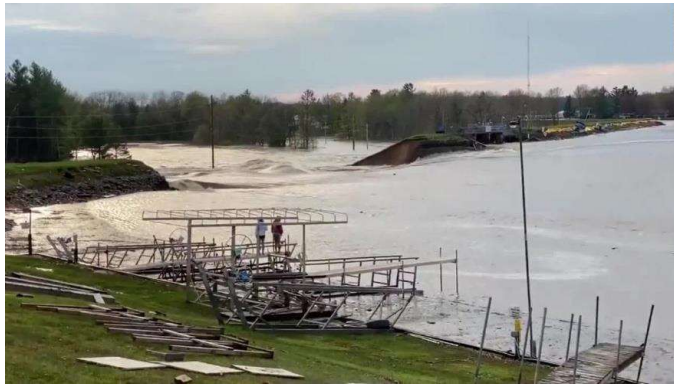
Failure of Edenville dam  
(Height: 16.6m, crest length: 2km)

- 19 May, 2020, Edenville dam (earth dam, 16.6m high) failed
- Causing overtopping failure of Sanford dam downstream
- Miland city was flooded, more than 10,000 people were evacuated

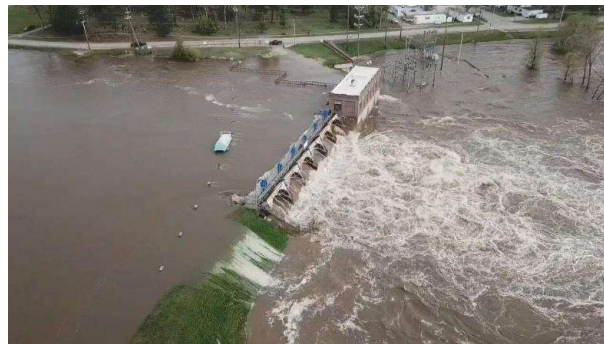
Overtopping of Sanford dam  
(Height: 11m, crest length: 481.3m)

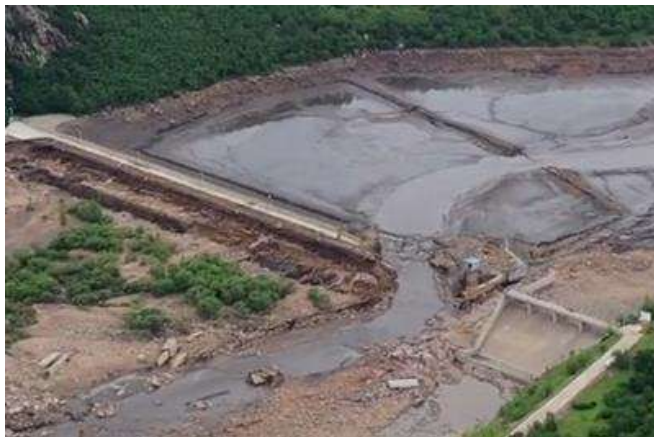
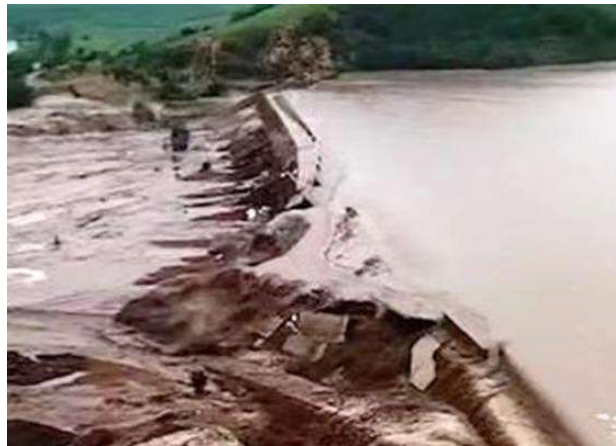
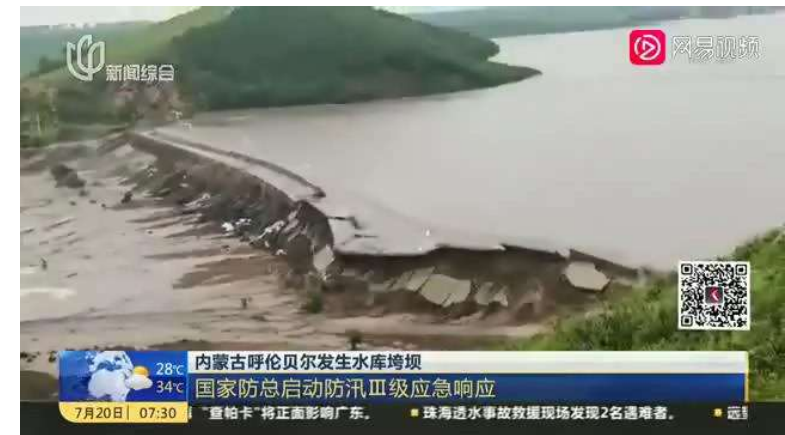
- Yong'an: embankment dam, 14.5m high, water storage capacity of 8hm<sup>3</sup>, completed in 1995
- Xinfa: earth dam, 10.6m high, water storage capacity of 38hm<sup>3</sup>, first impounding in 1959
- Yong'an failed due to over standard flood, causing failure of Xinfa dam downstream

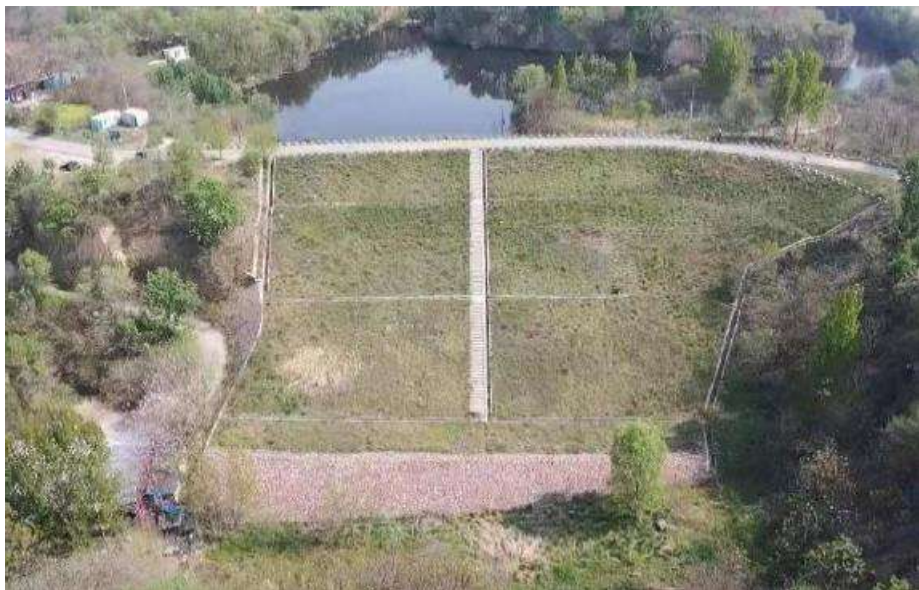
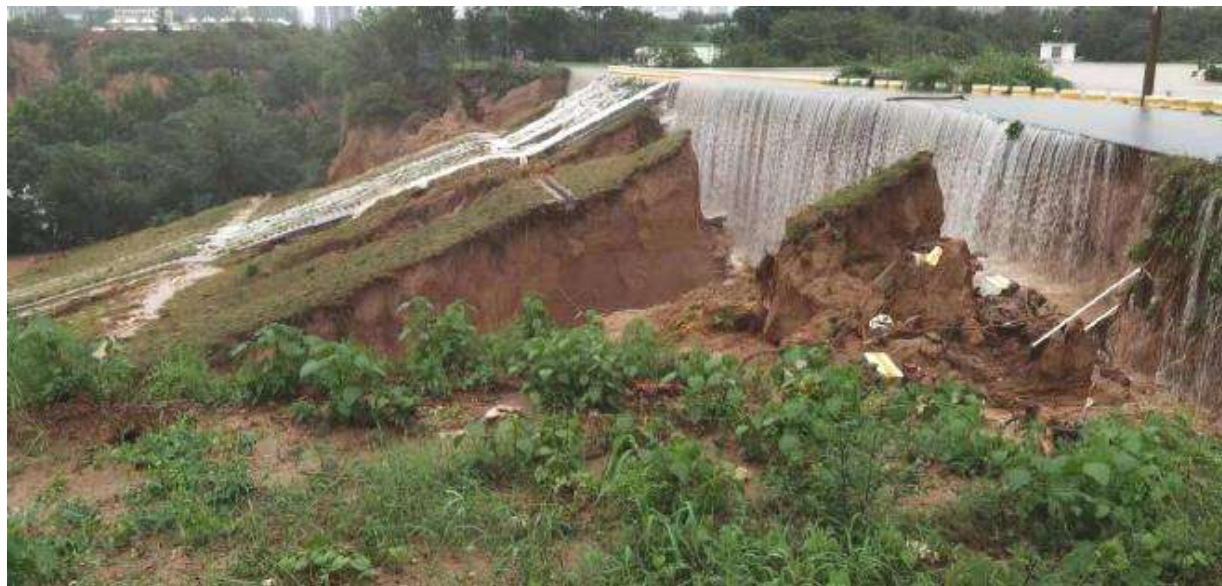
## Guojiazui earthfill dam: 7.5 hours' overtopping in 2021 in Henan Province, China

Although the downstream slope was seriously scoured, the dam did not break due to the asphalt concrete pavement on the dam crest and the concrete steps on the downstream slope

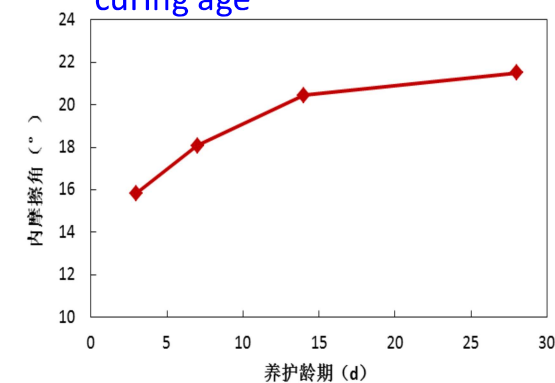
Internal friction angle with curing age

- Residual strength increases when the confining stress is increased
- Cohesion force and friction angle increase when the curing age is increased
- The cohesion force at 28d increases by 22% compared with the cohesion force at 3d, while the internal friction angle increases by 36%

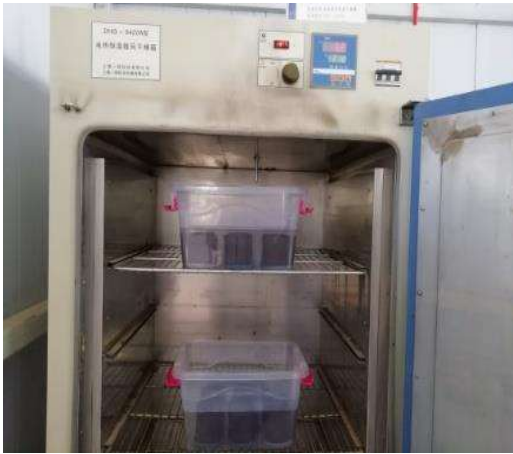
**Dry-wet cycle**

- Immersed for 5h at  $20.0 \pm 2^\circ\text{C}$
- Drying for 42h at  $71 \pm 3^\circ\text{C}$

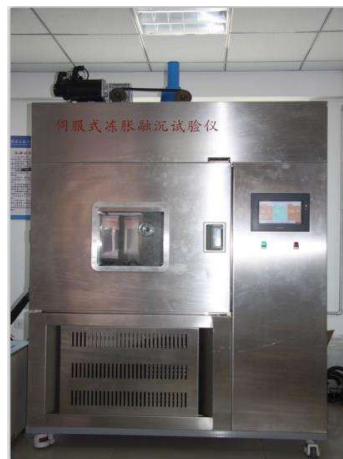
**Freeze-thaw cycle**

- Freeze temperature:  $-23^\circ\text{C}$ , for 24h
- Thaw temperature:  $\sim 21.0 \pm 1.7^\circ\text{C}$ , for 23h

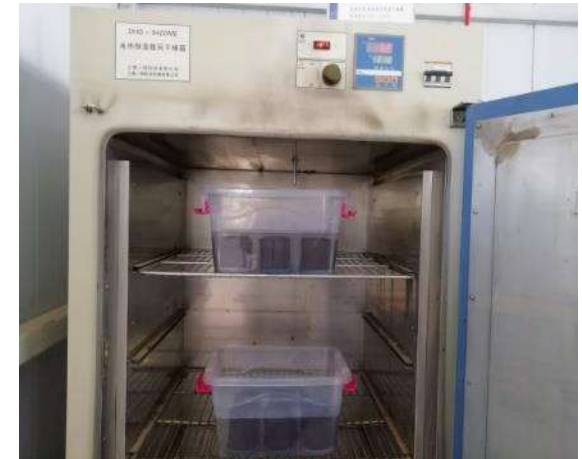
**Immersion test**

- Temperature:  $20.0 \pm 2^\circ\text{C}$

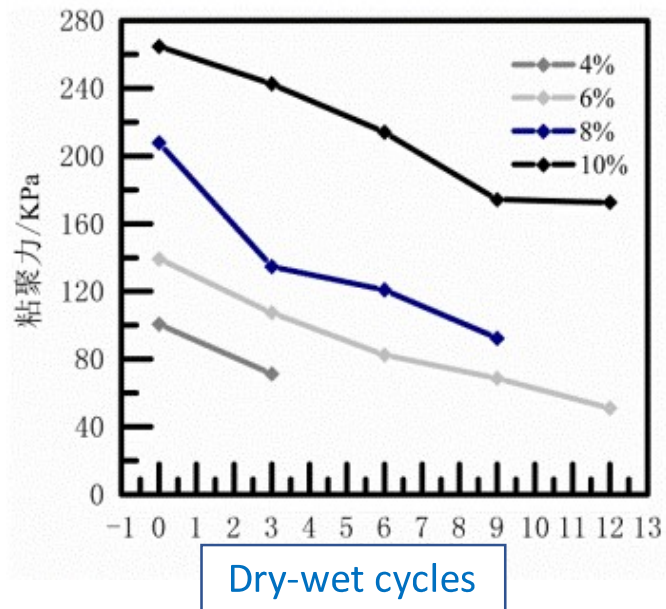
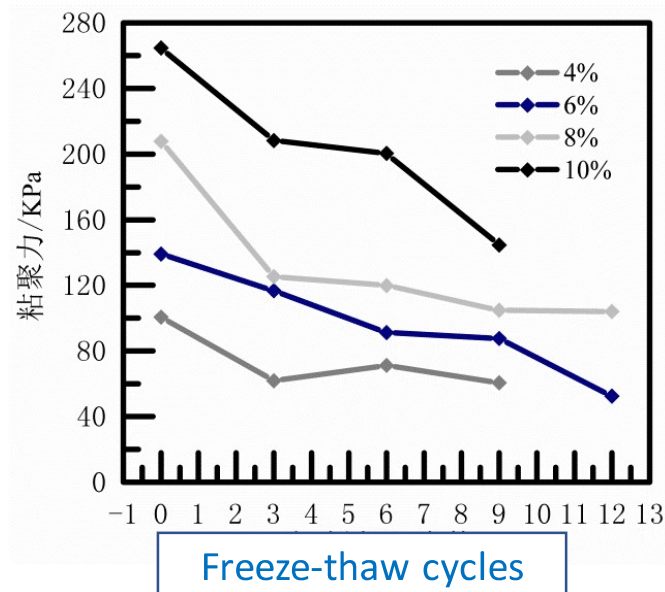
## Variation of cohesion of cemented soils under different environmental conditions

- Resistance to severe environmental is influenced by cementitious materials content
- The more the cementitious materials, the greater the durability of cemented soils

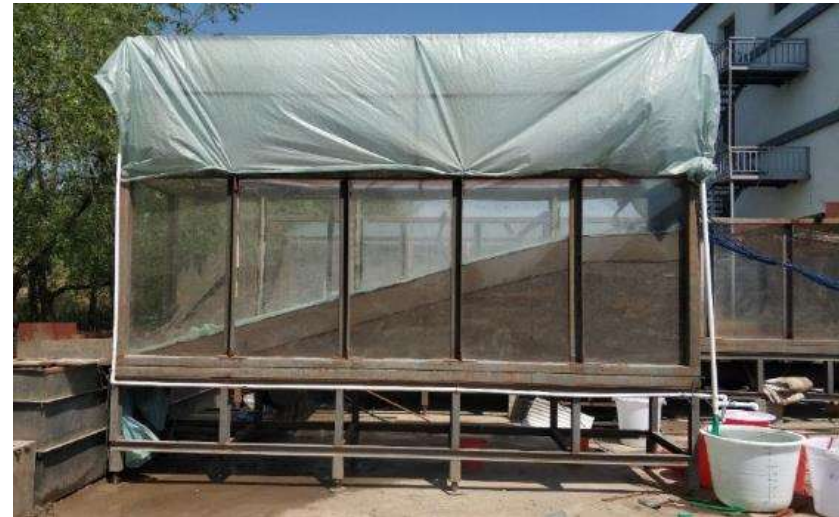
- **Clayey soil vs cemented soil** (Cementitious materials: 1% lime + 1% cement + 4% FA)
- Rainfall intensity 3.5mm/min, Rainfall 70mm
- Dry-wet cycles: 25

Clayey soil

Cemented soil

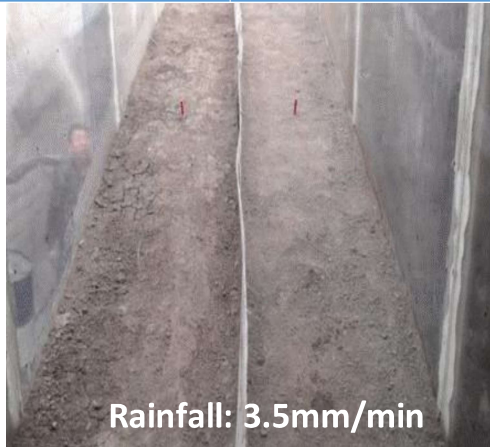
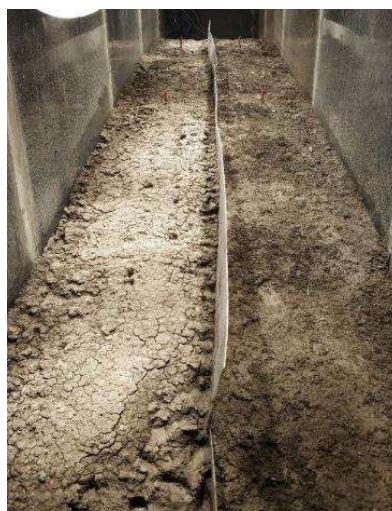
Clayey soil

Cemented soil

Mass loss of clayey soil is much greater than that of cemented soil

- Mass loss of clayey soil after 25 dry-wet cycles: 4%
- Mass loss of cemented soils: 2.3%

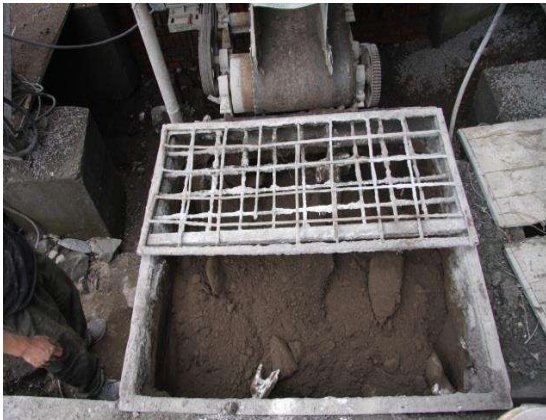
- Dimension of the chute: length-10m, width-1m, height- 2.2m
- Soil: dry density  $1.59 \sim 1.63\text{g/cm}^3$ , Moisture content: 20% ~ 22%
- Cementitious materials: 10%
- Curing: 28d, UCS:  $>4\text{MPa}$

Mixing of cemented soil

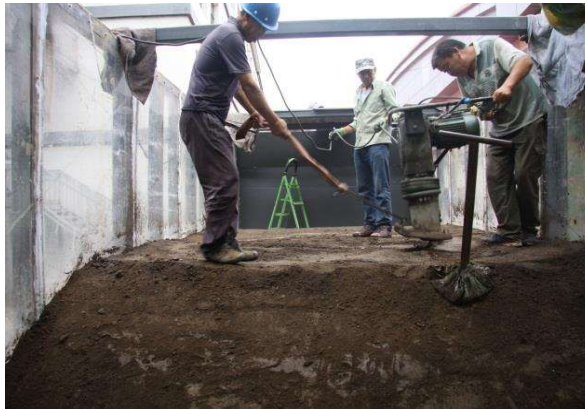
Compaction of cemented soil dam

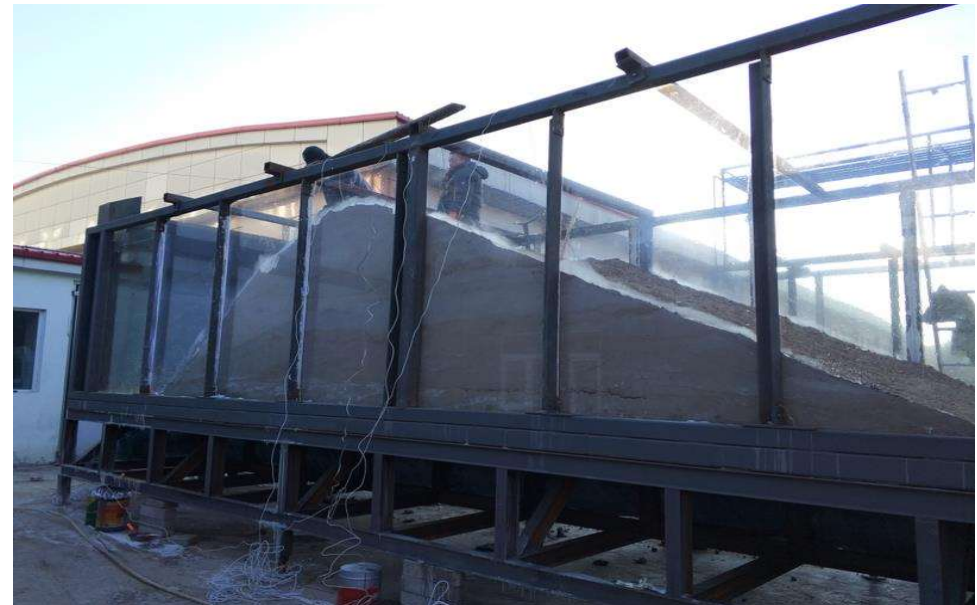
- overtopping flow: from 0.05m<sup>3</sup>/s to 0.26 m<sup>3</sup>/s in the first 16hrs and kept the flow for the rest 28hrs
- width of overflow edge: narrowed to 60cm and 30cm respectively when the test lasted for 28hrs and 36hrs
- the maximum overtopping height: 55 cm

Flow (m <sup>3</sup> /s)	Overtopping height (cm)	Overtopping time (h)	Hole width on the crest (cm)
0.05	5	8	0
0.13	10	8	0
0.26	16	12	0
0.26	30	8	60
0.26	55	8	30

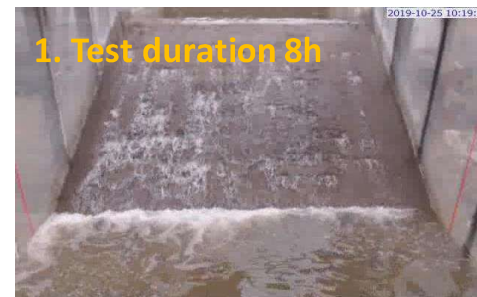
Overtopping height 5cm

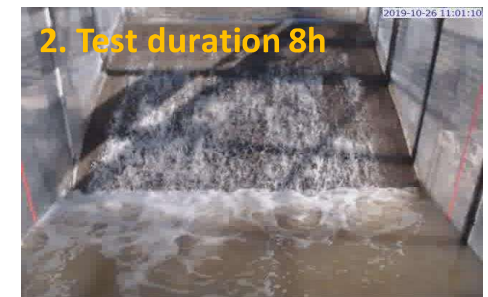
Overtopping height 10cm

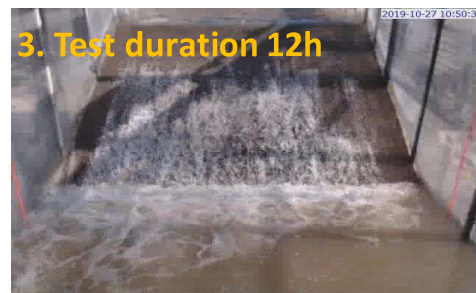
Overtopping height 16cm

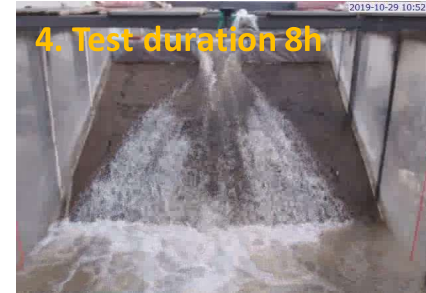
Width of overflow edge 60 cm

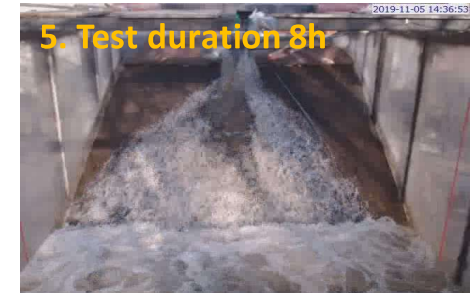
Width of overflow edge 30 cm

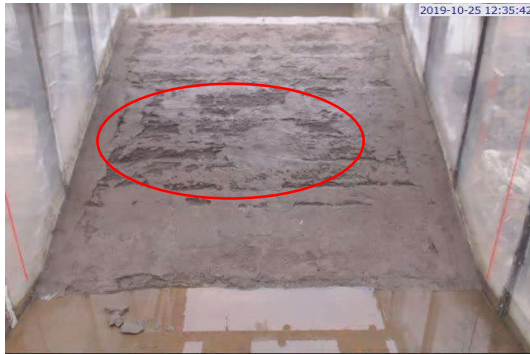
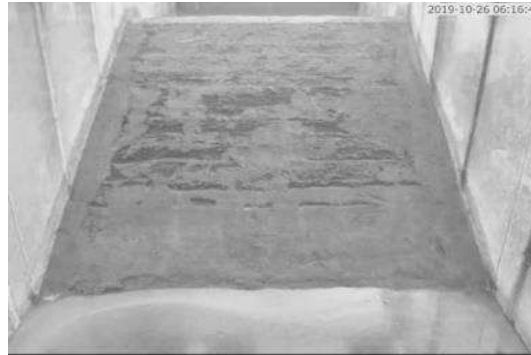
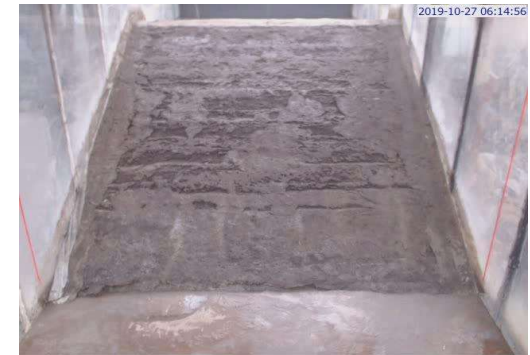
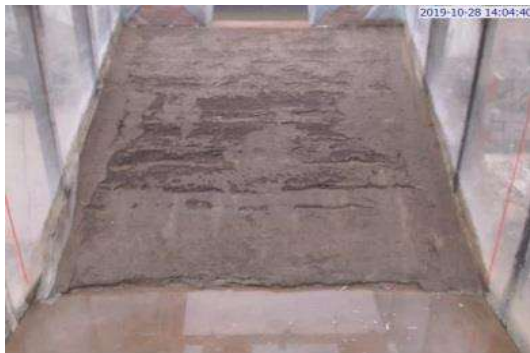
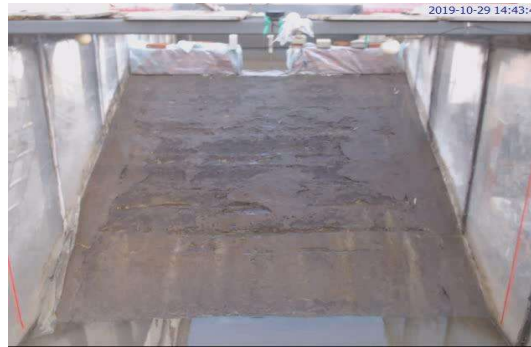
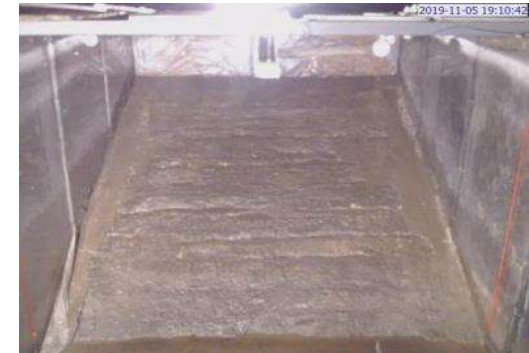
**overtopping 4h**

**overtopping 8h**

**overtopping 16h**

**overtopping 24h**

**overtopping 32h**

**overtopping 44h**

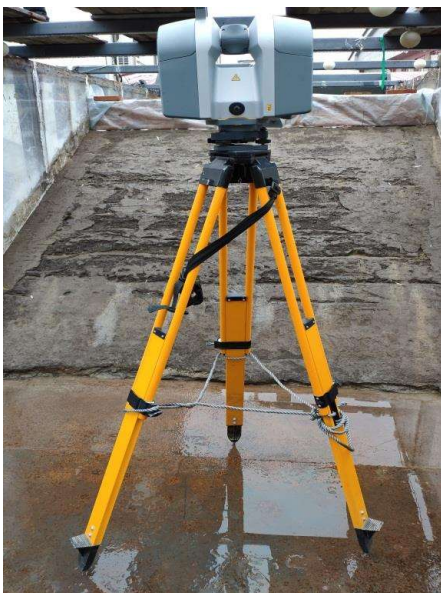
■ Erosion was monitored through 3D laser scanning technology

- Average erosion depth: 0.65cm
- Maximum erosion depth: 10cm

3D laser scanner

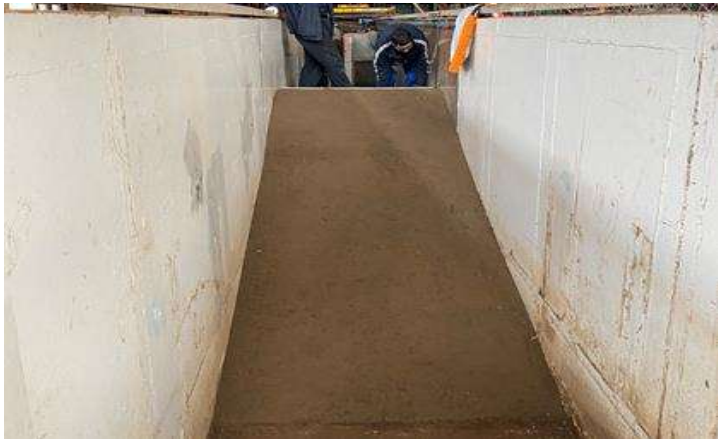
Earth dam model (1m high)

The downstream slope of the dam model is covered with cemented material by 20cm

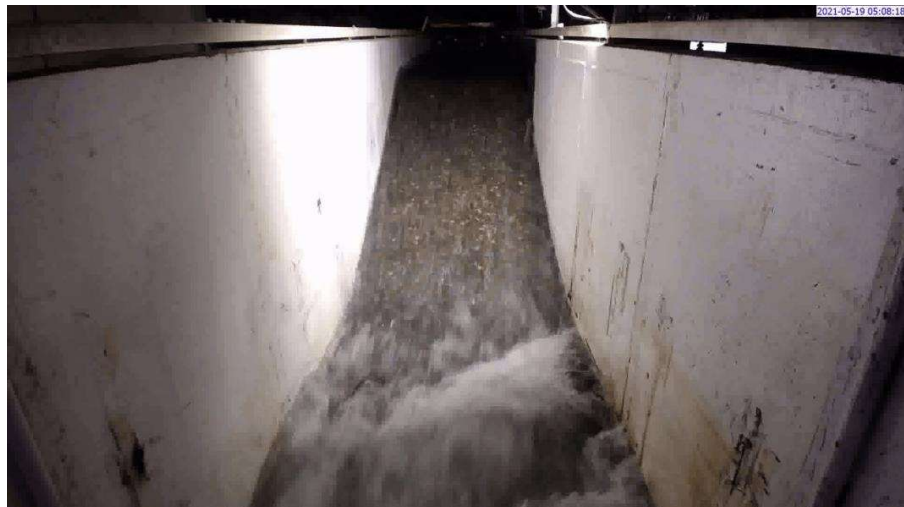
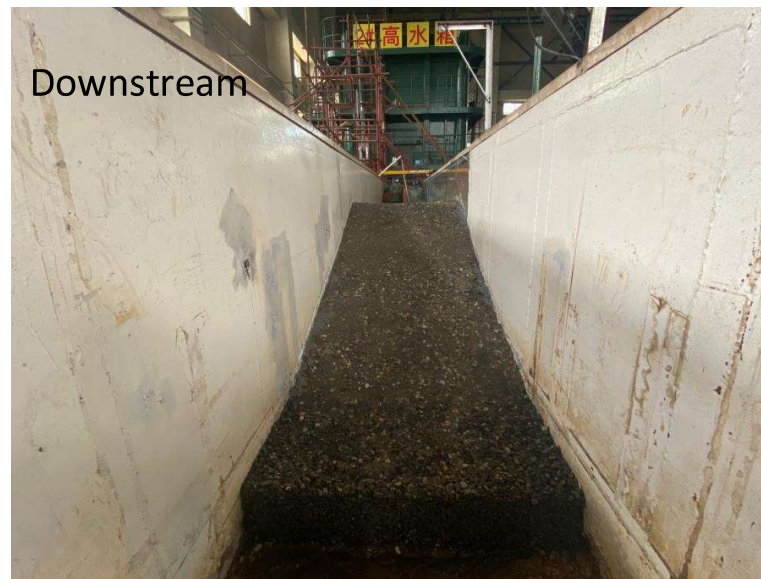
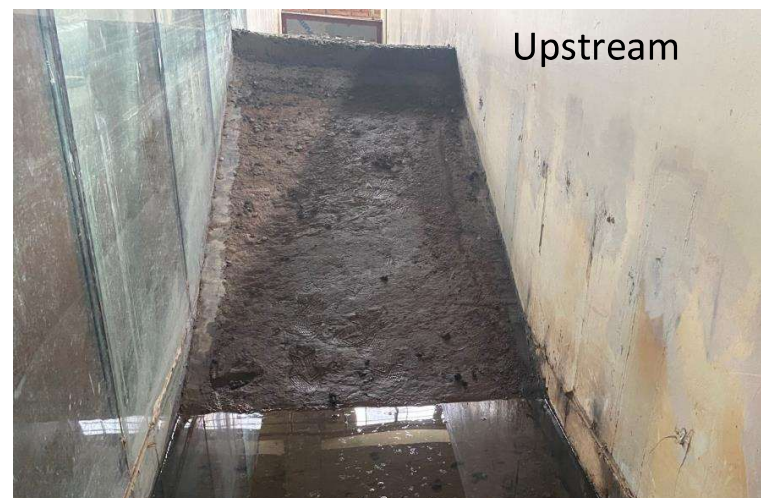
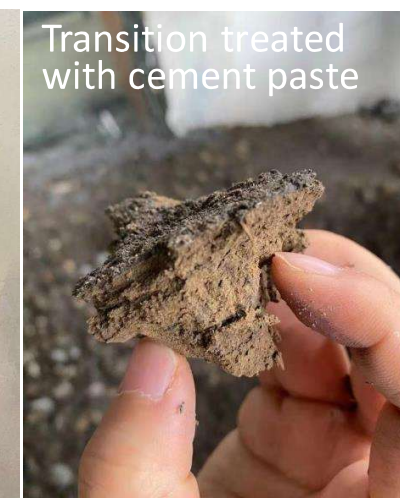
Overtopping for 50h  
Max. flow velocity 4.7m/s

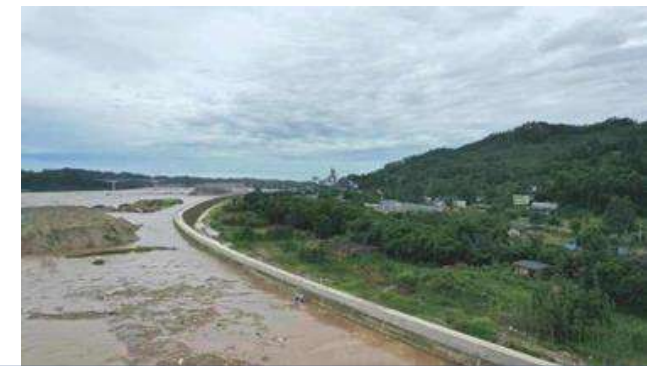
## Longxikou Levee

- 23 km long
- to be built on a soil subject to liquefaction in case of earthquake
- the thickness of this weak silty soil is between 3 to 8m
- cemented soil foundation: increase bearing capacity, decrease settlement

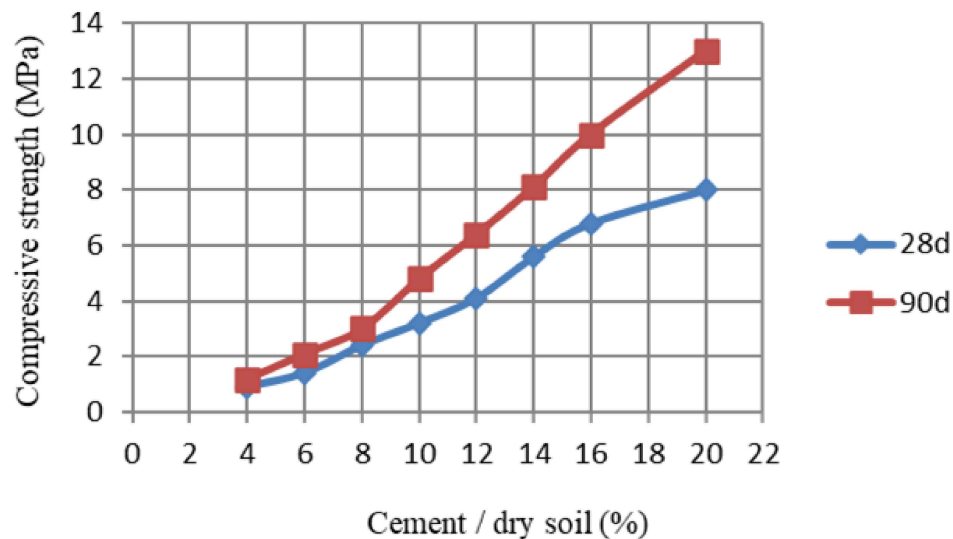
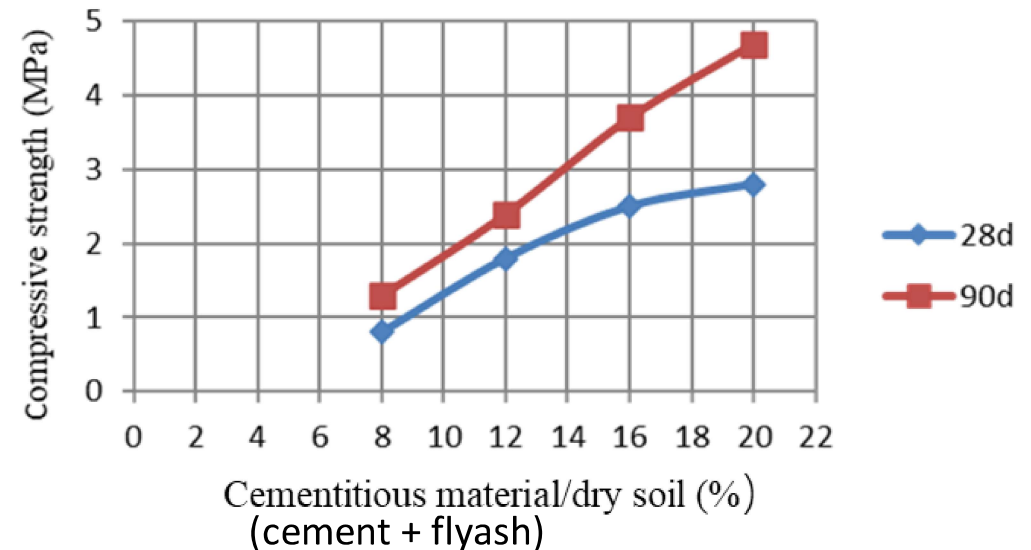
■ **Comparison tests of soil before and after treated: Cemented soil has higher mechanical strength and higher anti-permeability**

Soil: Sandy clay	Cemented soil	
Compressive strength	356kPa	$\geq 2\text{MPa}$	180d
Permeability	$10^{-3}\sim 10^{-4}\text{cm/s}$	$10^{-7}\sim 10^{-8}\text{cm/s}$	90d
Elastic modulus	3 MPa	2.5 GPa	
Friction	/	0.79	
Cohesion/MPa	0	0.69	
Disintegration in water	Yes	No	28d

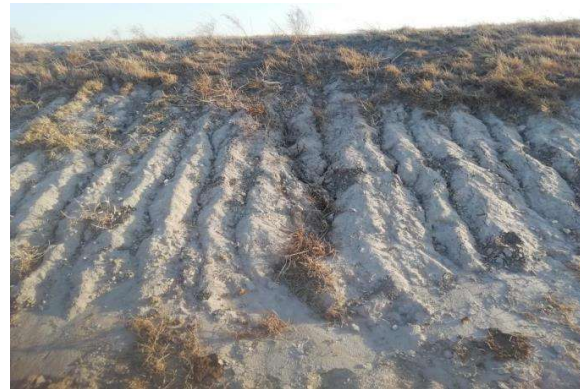
Scour marks at downstream slope

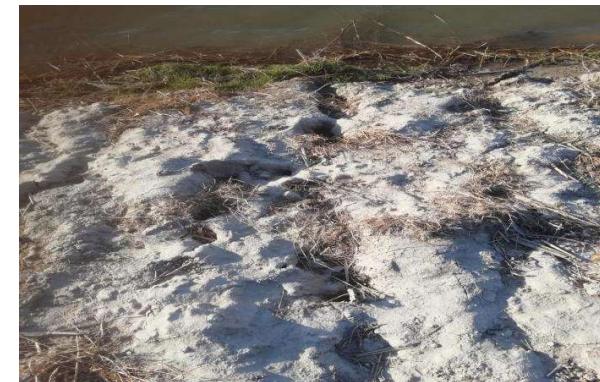
Scour marks at upstream slope

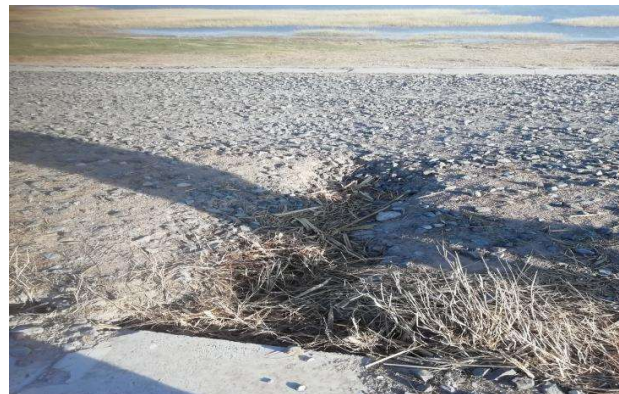
Uneven settlement

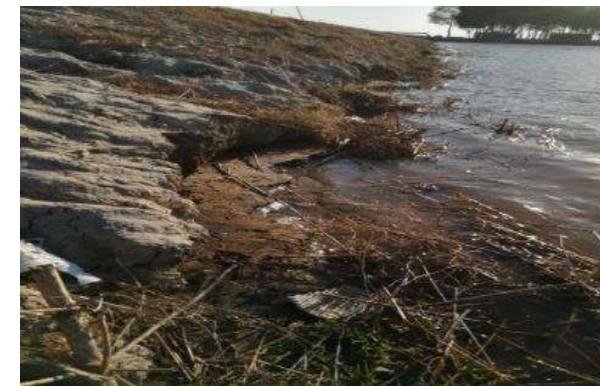
Bank caving

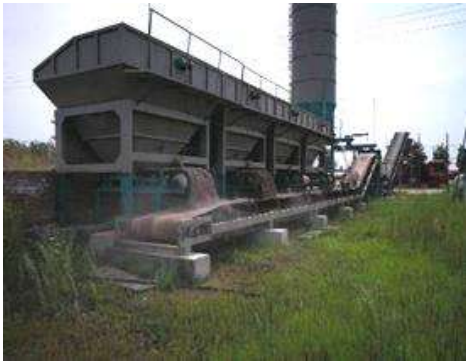
**Mix**

## ■ Construction

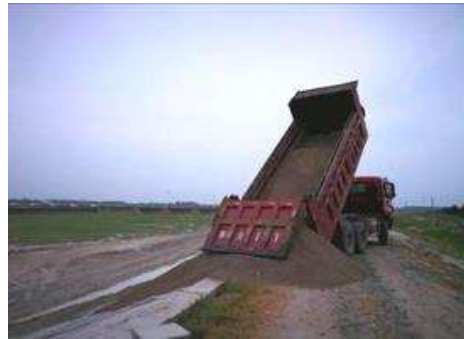
**Transport**

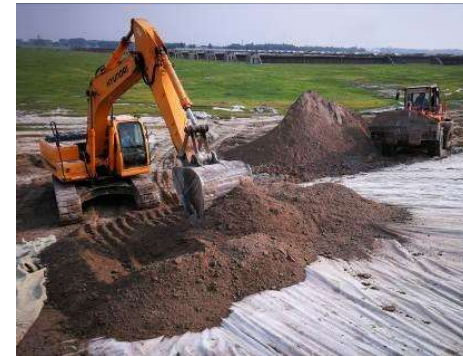
**Spread**

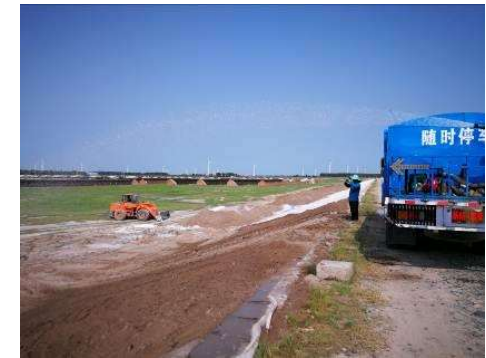
**Watering**

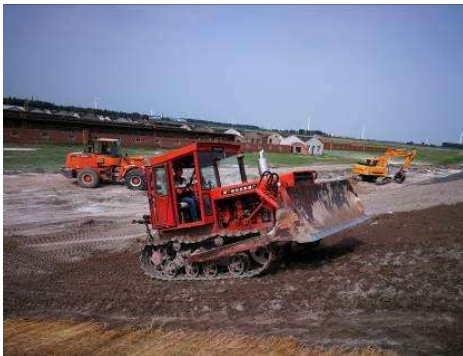
**Compaction**

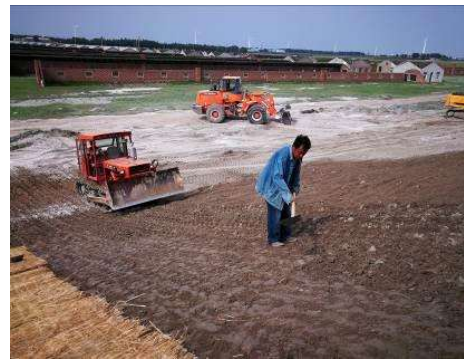
**Leveling**

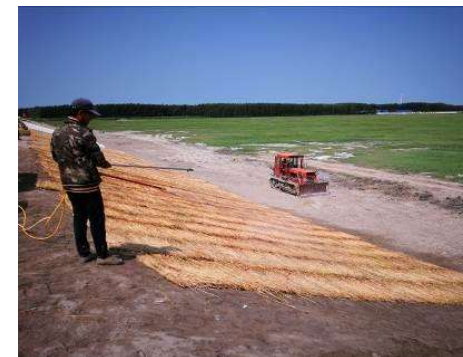
**Curing**

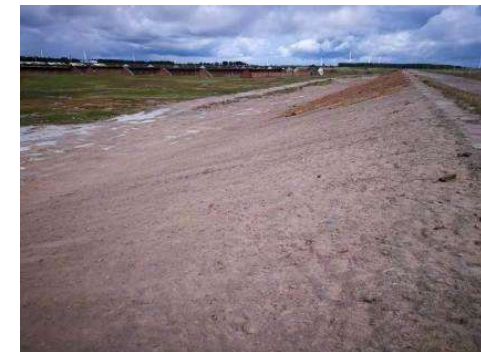
**Completion**

- 5000 m<sup>3</sup> Cemented soil in total
- During 2-year service, it suffered several rainstorms. There is no severe crack at the surface
- Through in situ test, UCS of Cemented Soil was about 4MPa.

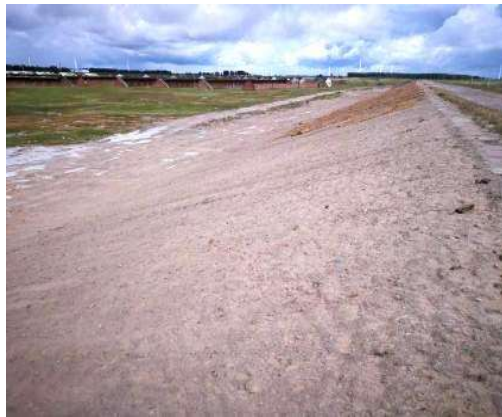
**CMD after construction**

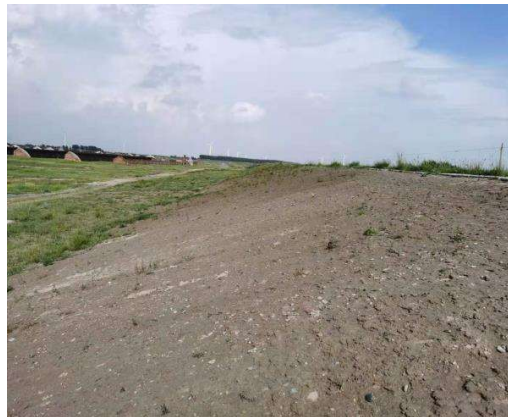
**CMD after nearly tow-year service**

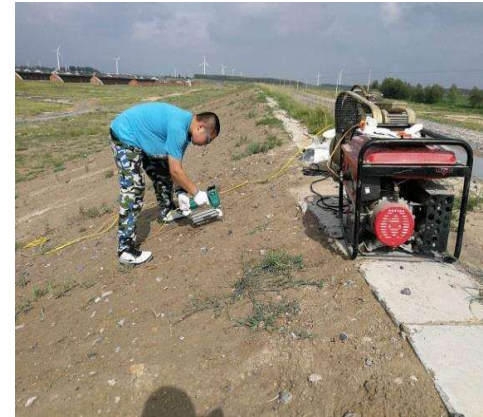
**In situ test**
